# QUINQUENNIAL INSPECTION REPORT

**TREGONWELL ALMSHOUSES & READING ROOM  
MILTON ABBAS  
DORSET**

**LISTED GRADE II\***

**18<sup>TH</sup> MARCH 2025**

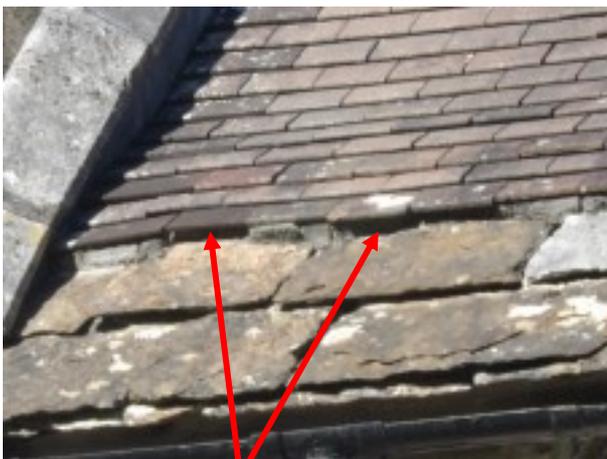
There is some lost pointing where the stone slates and tiles meet. I recommend this be replaced. There is a missing tile, and this should be replaced.

*Missing pointing.*

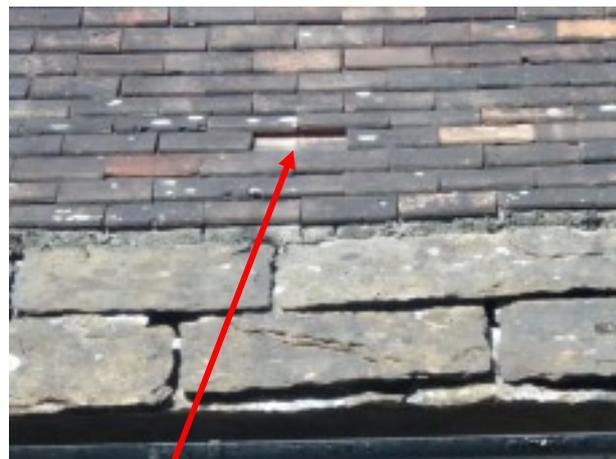
*Missing tile.*

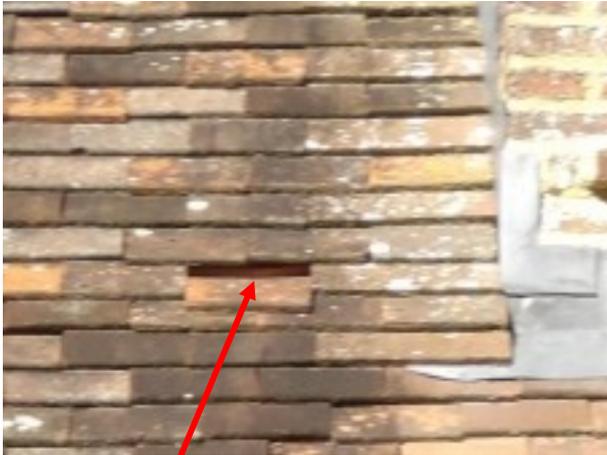
- c. The **south slope** - there is a snapped tile to the west of the chimney of house 3 - this should be replaced. There are fragments of tile in the valley. I recommend these be removed and the valley checked when the

**Snapped tile**

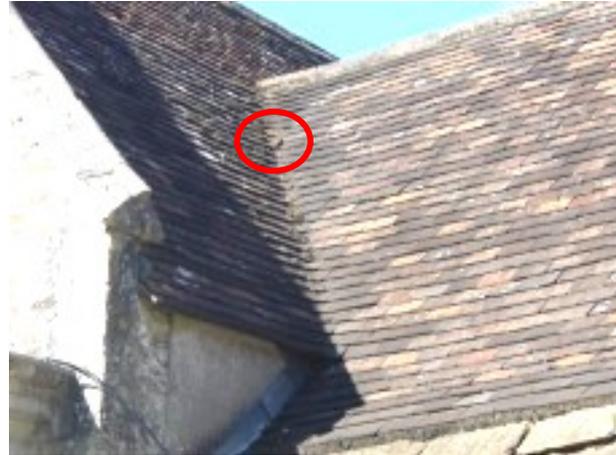
roofer is on site.

**Fragments of tile in valley**

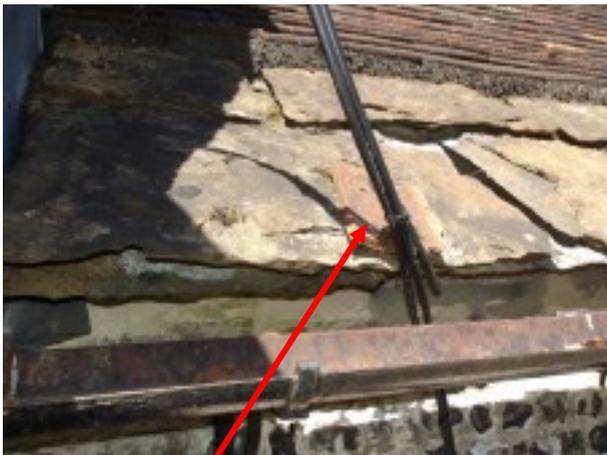
- d. There is a fragment of tile resting against an electrical cable at the west end. I removed it at the time of inspection. I was unable to see a damaged tile above - perhaps this is part of a tile which has already been replaced in the past.

**Fragment of tile resting against cable (removed)**

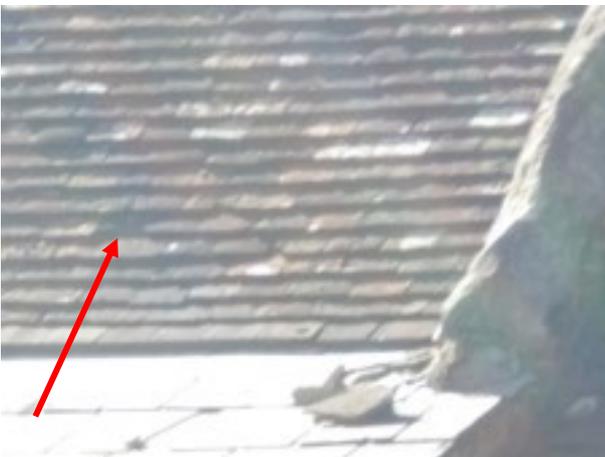
- g. The **east slope** of the roof of the reading room is of plain clay tiles with clay ridge. Moss is building up on this roof, particularly on the ridge, and I recommend that this be cleared. To the north of the houses, there is a snapped tile approximately 1 m from the north end and six courses above the slate roof. I recommend that this be replaced.

**Snapped tile**

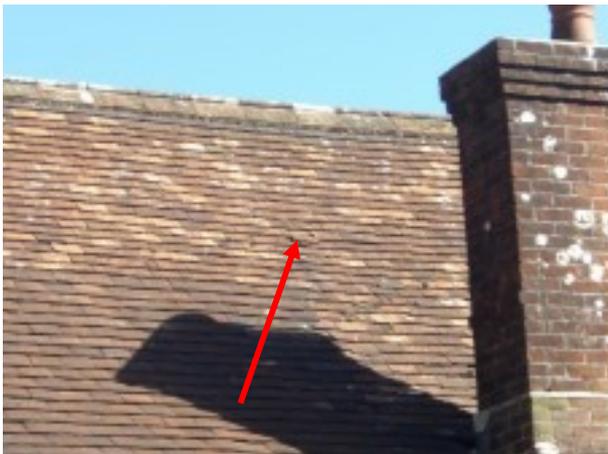
- i. To the **west slope of the reading room roof**: To the north of the houses, there is a fractured tile approximately in line with the chimney and 1.5 m beneath the ridge. This should be replaced.

**Fractured tile**

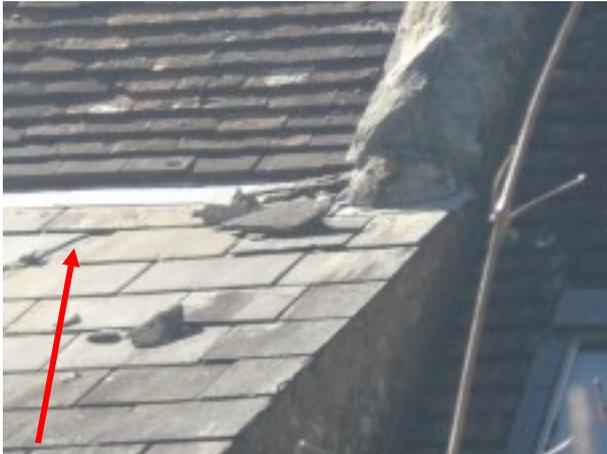
- j. The **slate roof over the kitchen** is slightly dished. This appears to be of long-standing and I am not greatly concerned by it at present. There is a snapped slate one course beneath the top and approximately 0.5 m from the north. This should be replaced.

**Snapped slate**

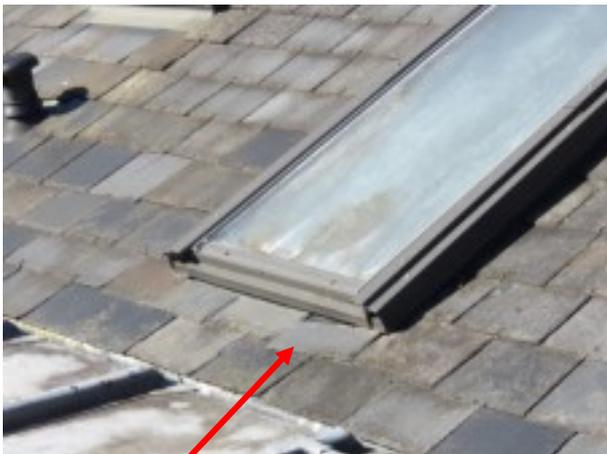
- k. The **WCs** have a slate roof with clips; this is generally in fair condition but a couple of the slates beneath the easternmost Velux are detached and should be resecured.

**Slate detached**

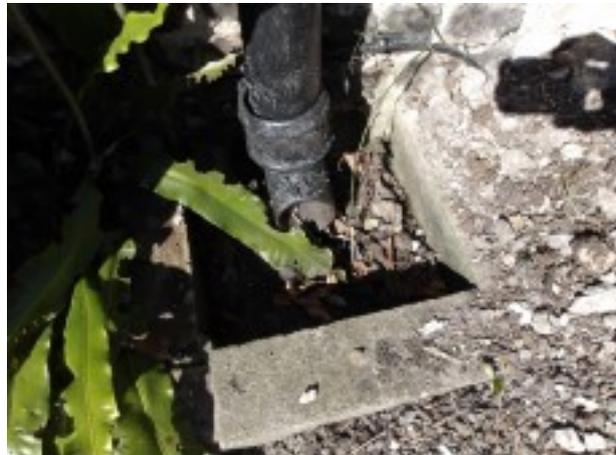
- a. To the **south** of the building there are cast iron gutters and downpipes and these discharge above gulleys. At the time of inspection the gulleys beneath the downpipes to houses 1 and 2 were obstructed and the gulleys to houses 3 and 4 were also partially obstructed on the south side. I recommend that the gulleys be cleared and that they be periodically checked to ensure they are freely flowing.

**Obstructed gulleys to the north**

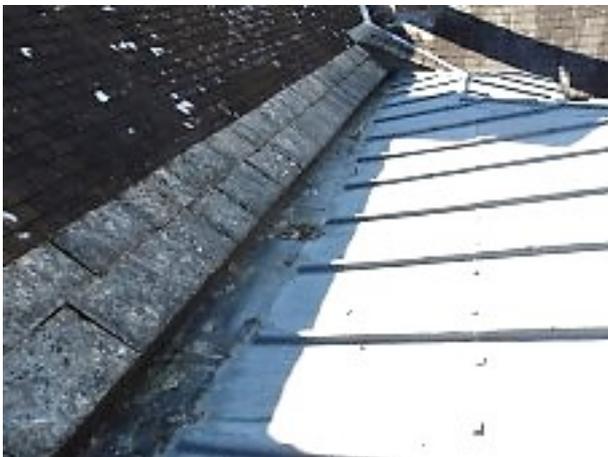
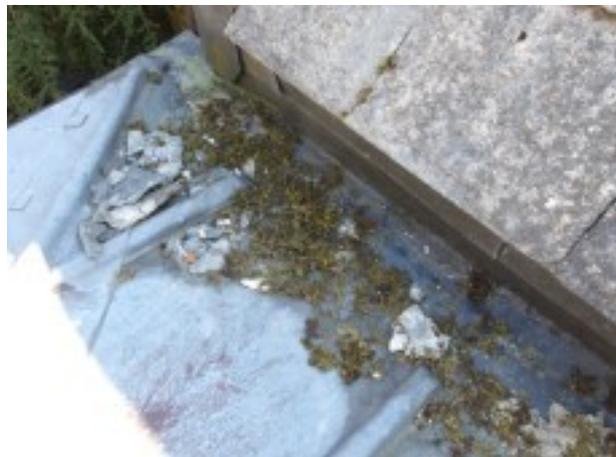
- c. To the **north side of the main buildings** there are UPVC gutters and downpipes which discharge into gulleys and are in fair condition.
- d. The south slope of the leadwork to the **rear roofs of houses 1 and 2** is in fair condition. It falls to a valley gutter, which is in fair condition and relatively free of debris although there is a little moss beginning to build up. I recommend that the valleys be cleared at the same time as all the other rainwater goods.
- e. The lead roof to the **north of houses 3 and 4** discharges into a valley gutter, which is littered with debris and should be cleared.

**Valley gutter littered with debris which should be cleared**

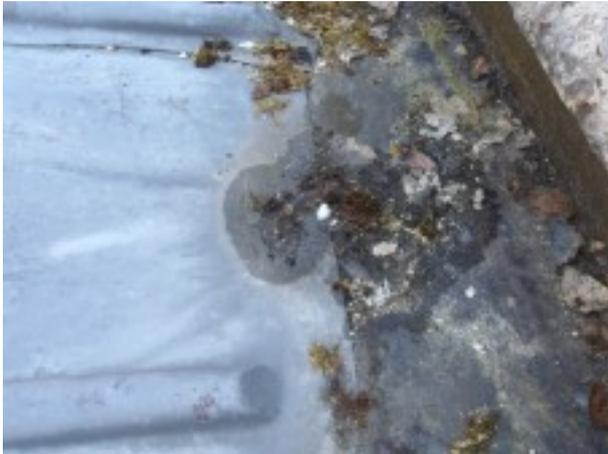
- f. At the bottom of the 6<sup>th</sup> bay from the east the leadwork dips and there is ponding. I am not particularly concerned by this at present, unless there are indications of leaking found beneath.

**Leadwork dips & water ponding**

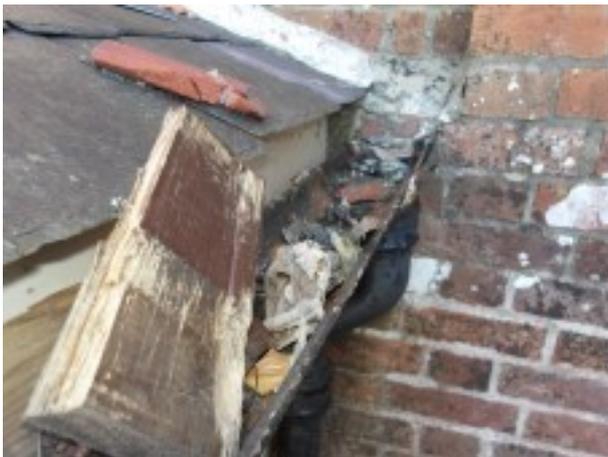
- g. **The outbuildings** have cast iron guttering and a cast iron downpipe. At the time of inspection the gutter was largely obstructed; it also has leaking joints. I recommend that it be cleared and the leaking joints resealed. The rainwater goods also due for redecoration.

**Debris in gutter**

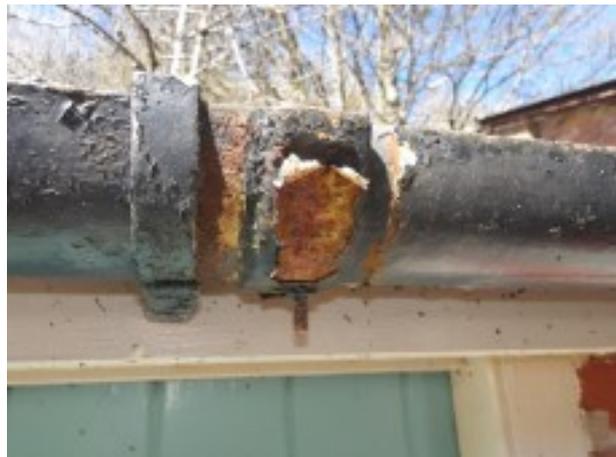
**Rusting & leaking joint**

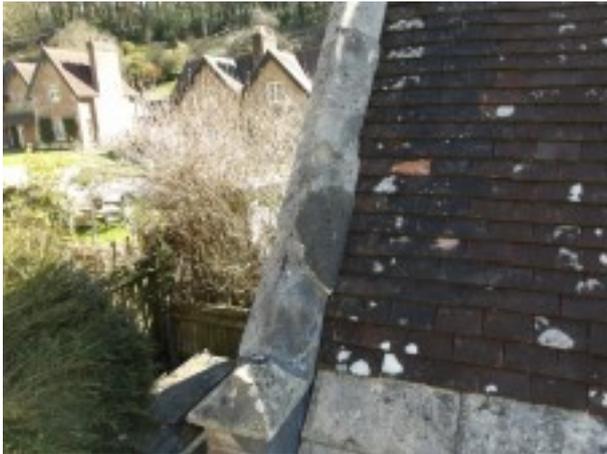
- a. There are upstand walls with stone copings. The coping at the northeast corner is heavily decayed. Mortar repairs have been undertaken in the past with inappropriate Portland cement mortar. Much of this has now been lost and is lying on the lead roof beneath and there is further decay of the stone. I recommend that the lowest coping stone here be replaced. Ideally the second lowest stone would also be replaced at the same time. This could possibly be deferred for another five or even 10 years, but if the cost of access is significant, it would make sense to do it at the same time.

**Decaying coping stones**

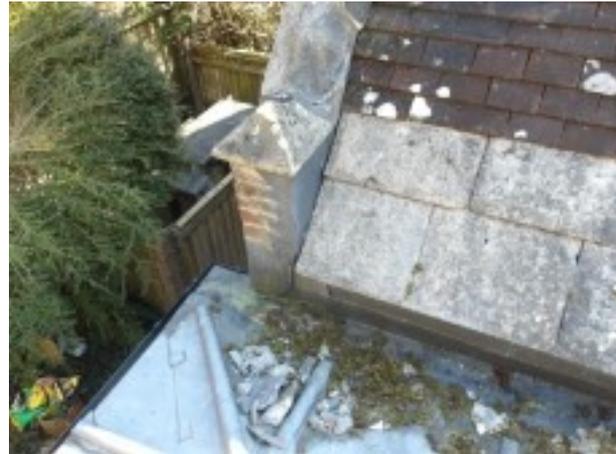
**Debris lying on roof beneath**

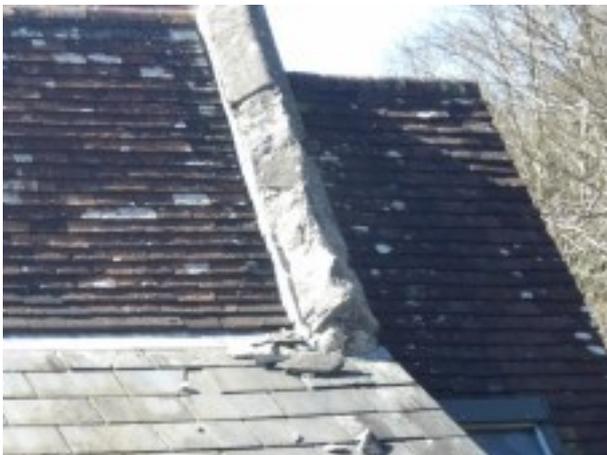
- b. The coping to the east side of the north end of the Reading Room is heavily decayed. Mortar repairs have been undertaken in the past with inappropriate Portland cement mortar. This has now failed and is lying on the roof beneath. I recommend that the lowest two coping stones be replaced.

**Coping heavily decayed with debris on roof below**

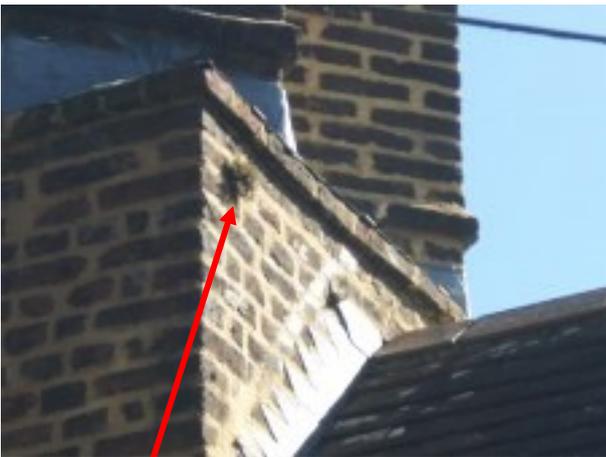
- d. There is a little vegetation growing near the northwest corner of the westernmost chimneys. This should be killed and, once dead, removed and the open joints should then be pointed.

**Vegetation**

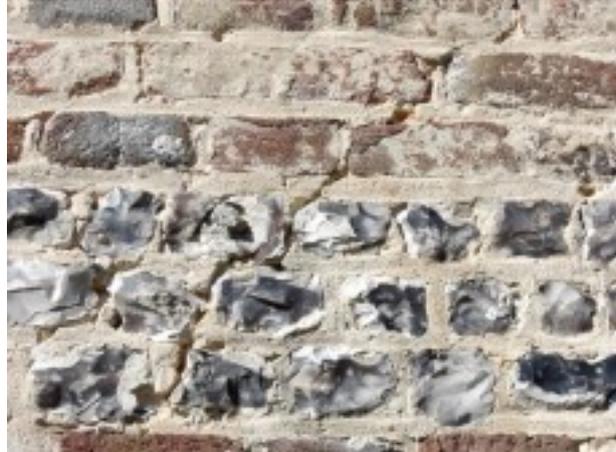
- g. The **south wall of house 1**: There is diagonal cracking to either side of the lintel over the door. To the west this has been repointed in the past using what appears to be a hard mortar, probably containing Portland cement. This pointing is coming away. I recommend that the crack here be repointed using an appropriate lime mortar. To the east the cracking has not been pointed in the past. The crack may be new but, if so, it is relatively minor. I recommend that the crack be raked out and repointed, and the date of this recorded. Then, if there is ongoing movement, the crack will re-open and could be measured to determine the rate of movement (which may be informative in determining the cause). A likely possible cause is damaged drainage, and if the crack re-opens, I suggest a camera survey of the drains be undertaken. I expect the specification for the pointing mortar will be recorded within the records of the refurbishment of 2008-2009, so this should be easy to match.

**Cracking new?**

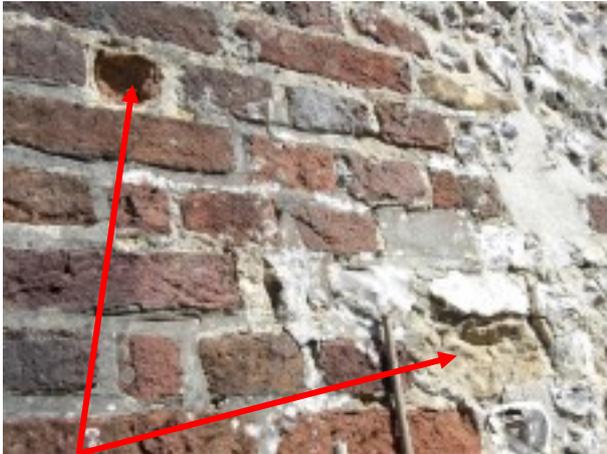
- k. The **west wall of the Reading Room** is of brick and flint. There is a rendered area at high level towards the south end. This wall has been patched in the past - in some places with lime, but in others with inappropriate Portland cement mortar. There are a few stones and bricks which are badly spalled and a little open pointing. I recommend that the most badly spalled masonry units be replaced. Where pointing can easily be removed by hand, I recommend it be taken off, and then any resultant deep open joints be repointed.

**Spalled bricks and stones.**

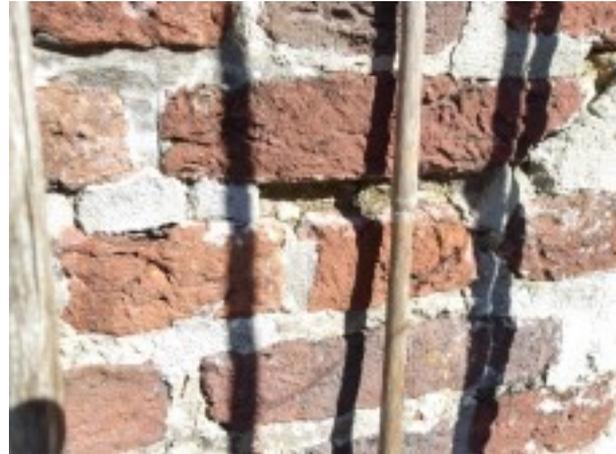
**Missing pointing**

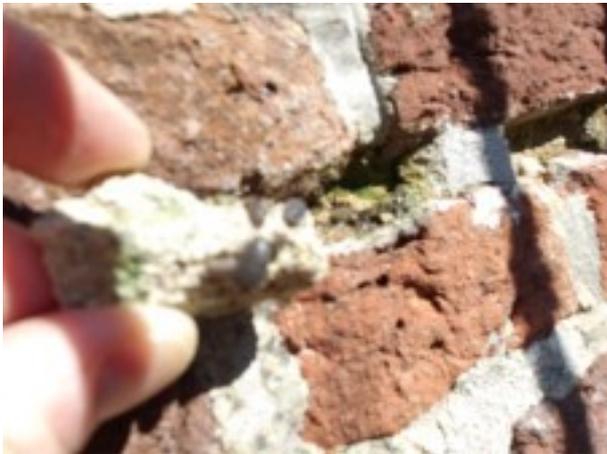
**Woodlice behind mortar - evidently loose for some time**

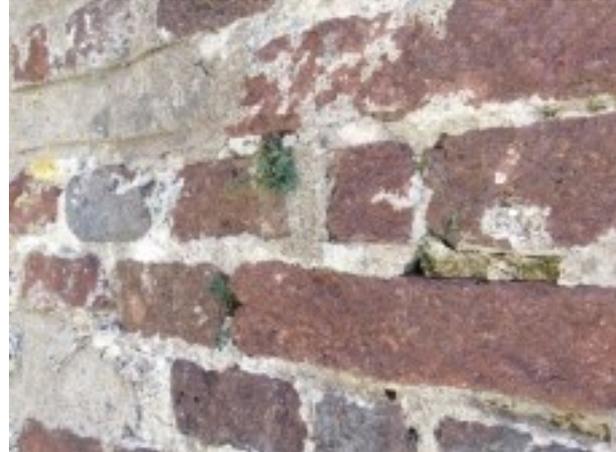
- i. The **north wall of the Reading Room** is of brick and flint. It has been repointed in the past with at least two different mortars. Some of the mortar appears loose and there is a stone which has fractured. I recommend that the mortar be removed where loose, and any deep open joints be pointed.
- m. I recommend that the fractured stone be de-frassed. It may be that there is enough sound stone remaining that no further action is required, but it is possible that new stone may need to be inserted.
- n. There is a little vegetation growing near the northwest corner, at around 2 m above floor level. This should be killed and, once dead, removed and the open joint in which it is growing should be pointed

**Vegetation & missing/loose mortar**

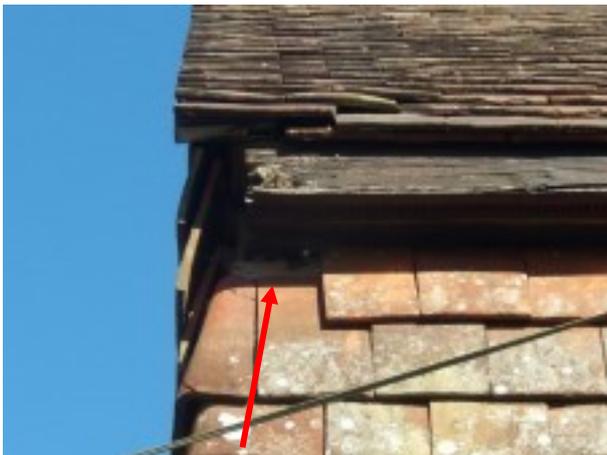
- o. The **north end of the Reading Room** (and to either side of this) has tile hanging at high-level. At least one of the tiles is missing and should be replaced.

**Missing tile at end of top course**

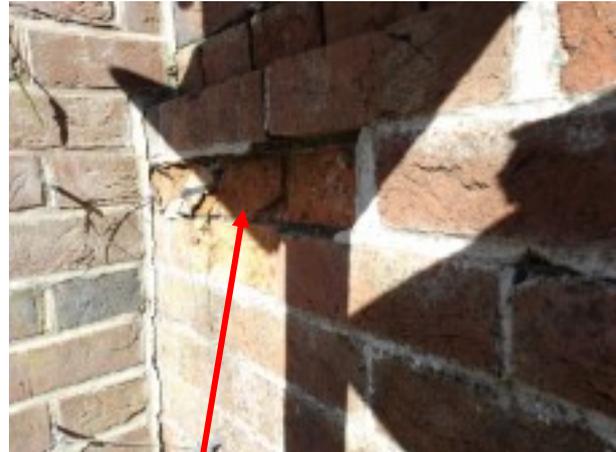
**Spalled bricks**

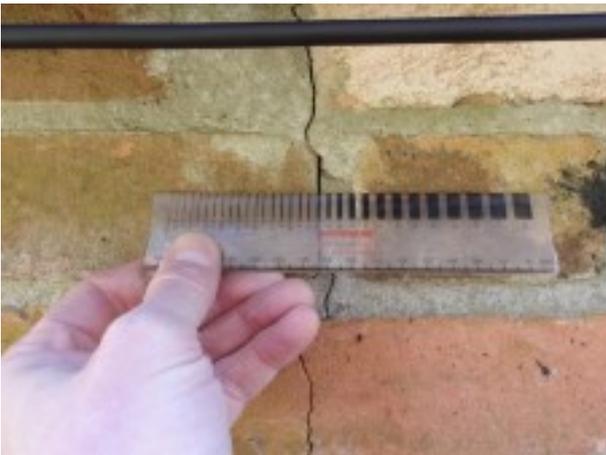
- t. There is vertical cracking approximately 3 m from the east end. At my last inspection this was approximately 1 mm - this is unchanged. This is probably due to thermal movement - there is no provision for expansion, and the pointing mortar is hard.

**Cracking 1 mm**

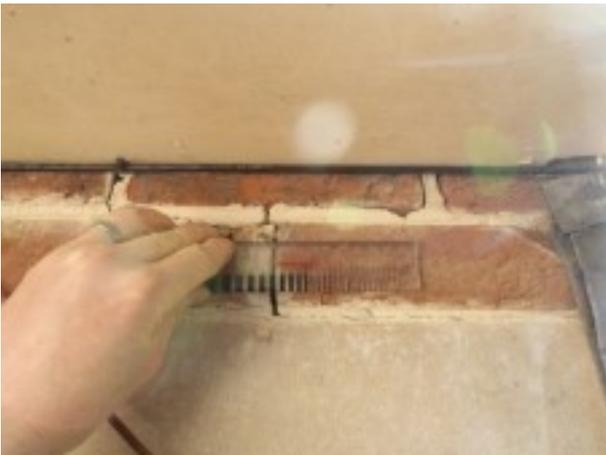
- w. The **north wall of the bathroom of house 3** was damp at the last inspection and I am pleased to report that it has now dried. There is cracking at high level measuring 3.5 mm at the widest point. I recommend that the open joints be filled.

**Cracking 3.5 mm**

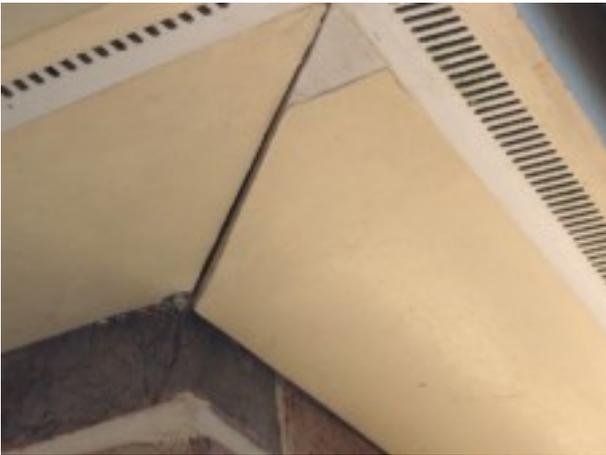
- c. In the northwest corner of house 1, the soffit has dropped and should be resecured.

**Dropped soffit.**

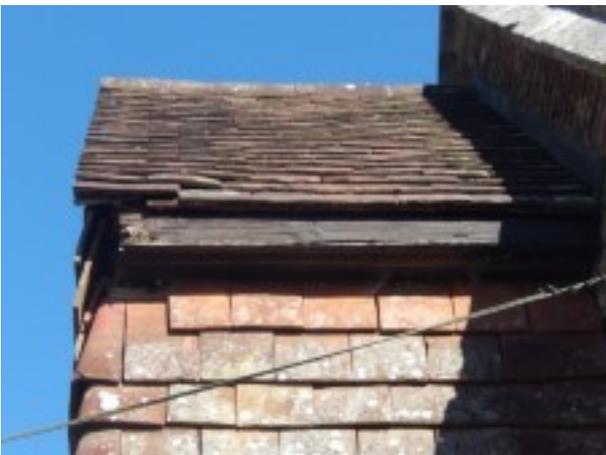
- d. In the northwest corner of the Reading Room the fascia is heavily decayed. I recommend it be replaced.

**Heavily decayed fascia**

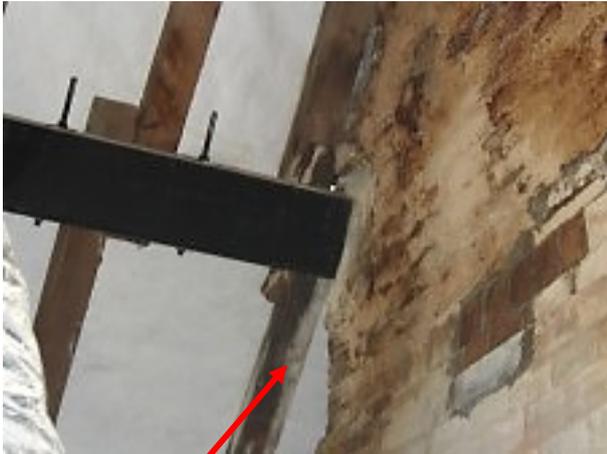
- a. The roof structure has been repaired/reinforced with steels at the end of the original purlins and ridge beam. The original rafters have historic woodworm damage and nails from former laths to the underside. There are new rafters in between the old. All appears to be in fair condition. There is a modern membrane above the rafters, which is in fair condition.
- b. There is historic staining as noted at (and which appears unchanged since) the previous inspection. The membrane to the roof should ensure that the roof is watertight even if there is a damaged or missing tile above.

**Stained rafter**

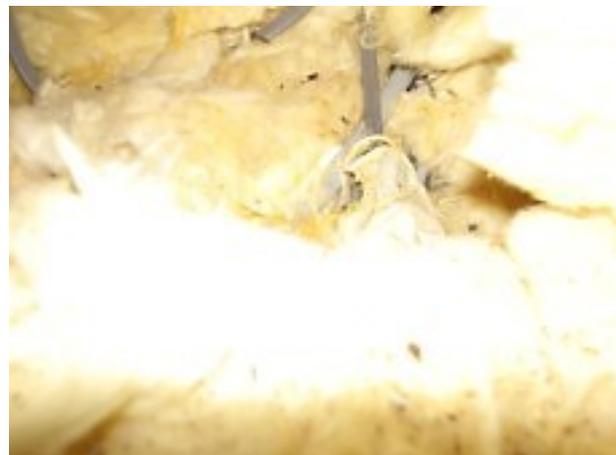
**Bat droppings**

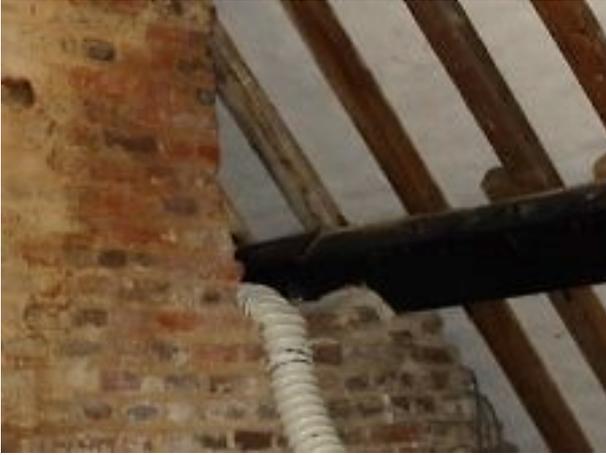
- f. There is a ventilation system, continually running, with flexible ducting. The ducting has been deformed/crushed where it passes over the wall between houses 3 and 4. This will reduce airflow, and I recommend that it be straightened. The spreadsheet records that this has been done, and perhaps it is less bad than at the last inspection, but it still looks deformed to me.

**Squashed ducting**

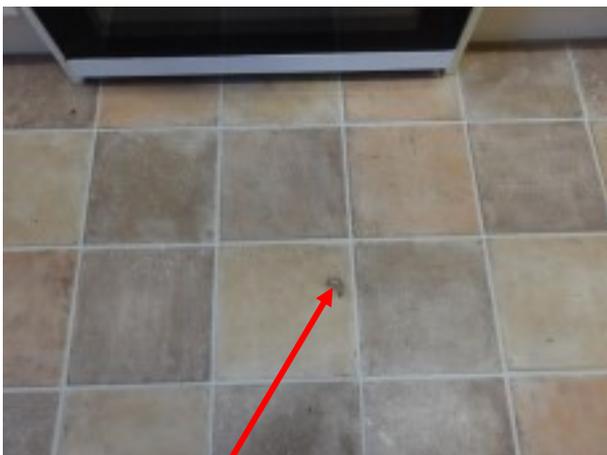
- c. The floor is of vinyl - there is some damage by the cooker; presumably the vinyl has been melted. The floor is otherwise in fair condition.

**Damage to vinyl**

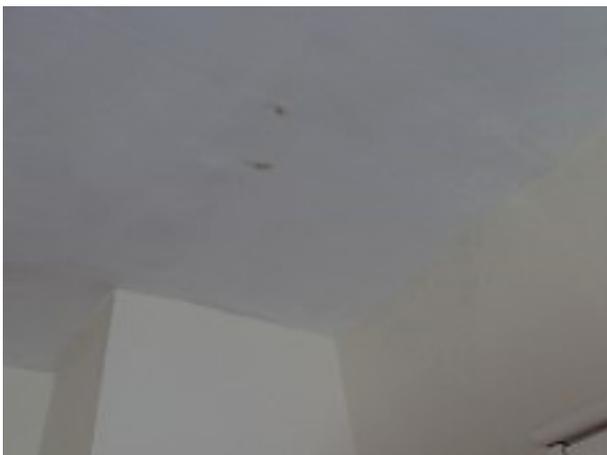
- a. The ceiling is papered and painted and generally in fair condition, but there is a small, isolated patch with damp staining approximately half a metre to the south and half a metre to the west of the northwest corner. There is a tile missing from the roof above and this may be the cause of the dampness - although the roofing membrane should keep the building watertight even if there is a lost tile.

**Damp staining**

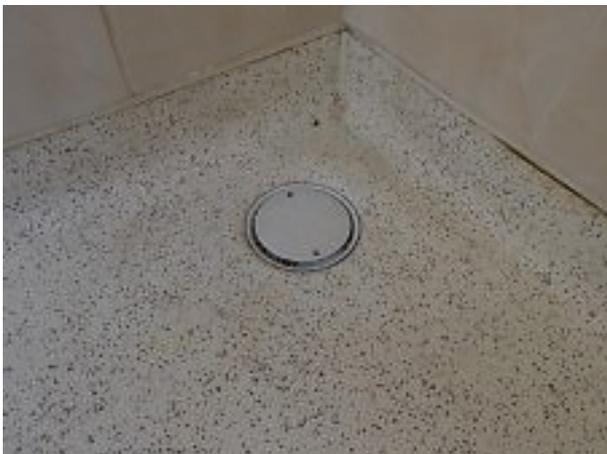
- c. The floor is of non-slip vinyl with coved skirting. As previously noted, there is a small gap beside the toilet which has not been welded, and I recommend that this be repaired.
- d. The vinyl is bulging around the shower outlet and stained around the WC. The coved skirting is also coming away in places. It is possible that water is getting behind the tiles where the grout is split and/or where the coved skirting has come away and then been trapped beneath the floor by the outlet and this has caused the flooring to bulge. Alternatively, there could be a problem with the sealing of the outlet itself. Either way, in order to resolve this the flooring will probably need to be replaced. It should be allowed to dry before new vinyl is laid.

**Bulging and stained vinyl**

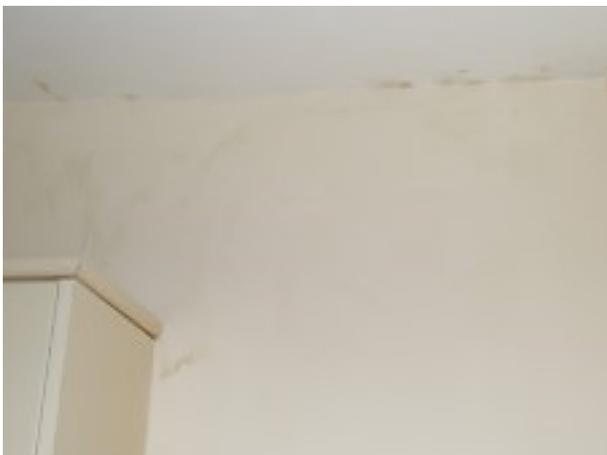
- a. The ceiling is papered and painted. There is a little damp staining at the western end where it abuts the chimney, but this is far reduced since the last inspection. I recommend that the decorations be ‘touched up’ in these areas.
- b. The walls are papered and painted, with tiling above the worktops. There is a little staining to the west wall which was not noted at the previous inspection and may be new.

**Staining to wall and ceiling**

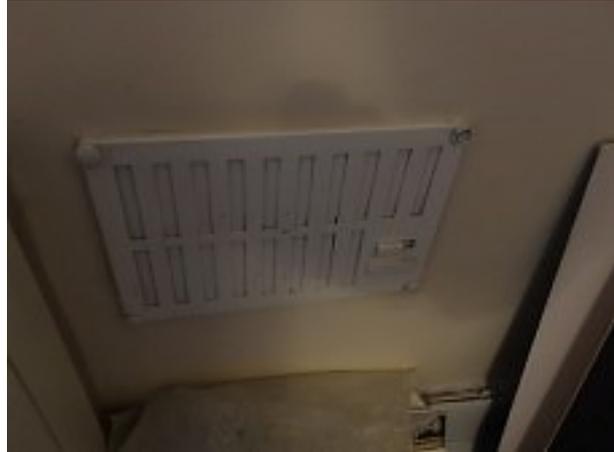
**Closed vent**

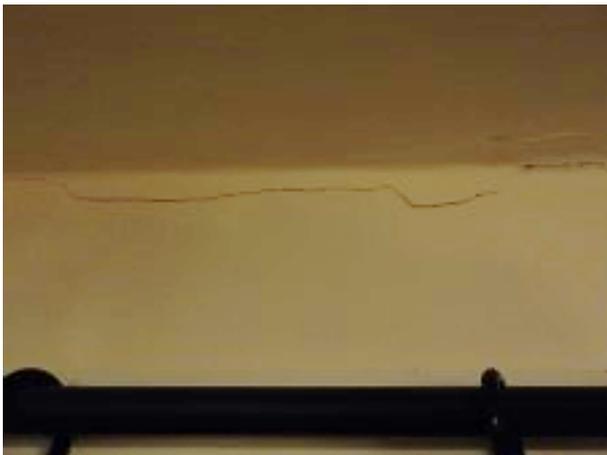
- a. The ceiling is plastered and painted and in good condition apart from where a fixing has 'blown' above the north edge of the bathroom doorway - I recommend that this be repaired.
- b. The walls are plastered and painted and in fair condition. There is a little horizontal cracking above the door to the corridor - I recommend this be repaired and redecorated.

**Cracking above door**

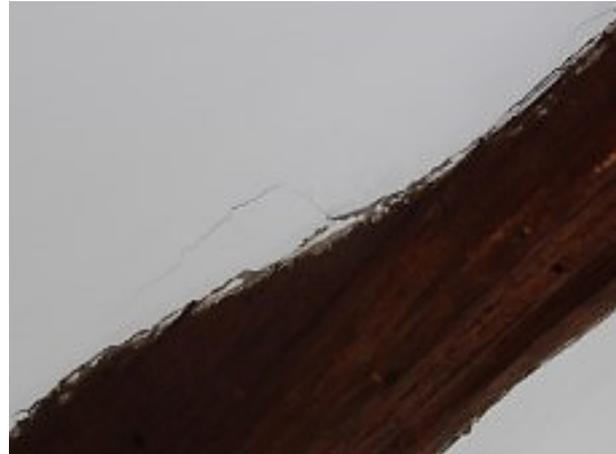
**and against timbers**

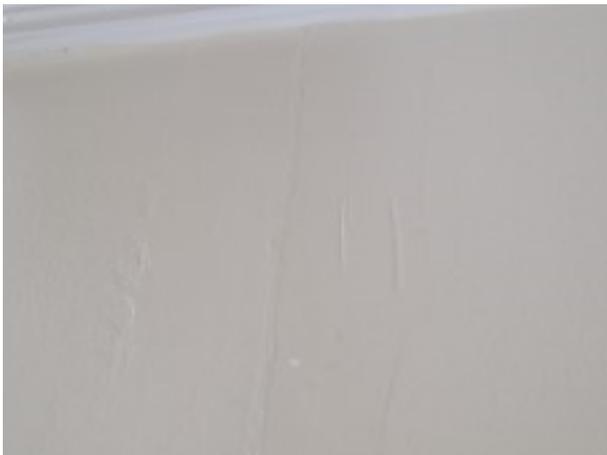
- b. The **walls** are plastered and painted with dado panelling at low level and a picture rail. The cracking noted at the previous quinquennial inspection has been filled and the walls redecorated during the quinquennial period, but the positions of the cracks are still evident. I recommend when the walls are next decorated, they be sanded smooth.
- c. To the west wall the cracks have re-opened slightly, indicating ongoing movement, but only to hairline width.

**Hairline cracks**

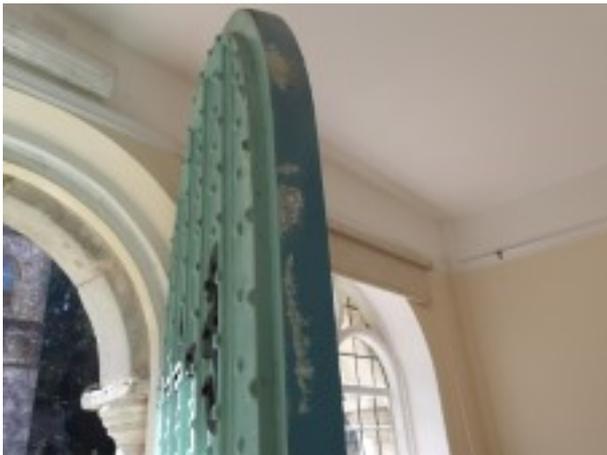
- i. The main entrance door binds slightly at the leading edge. The locations in which it is binding can be seen by scarring to the paint on both the door and frame. The door is still operable, and I expect it has simply swollen a little in the winter and will remedy itself in the summer...but then expand and bind again next Winter. It would be worth fixing.

**Scarring on door edge**

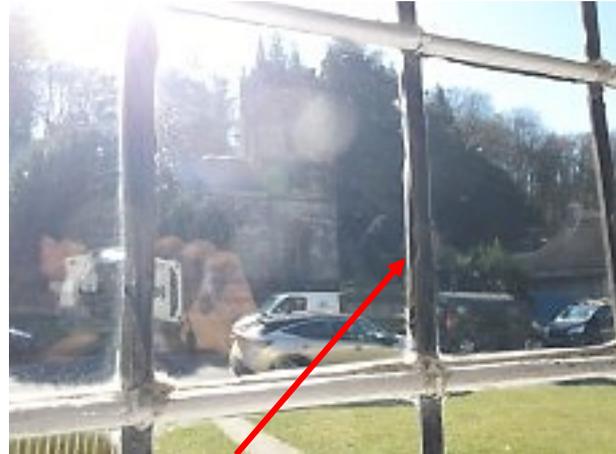
**Damaged comes**

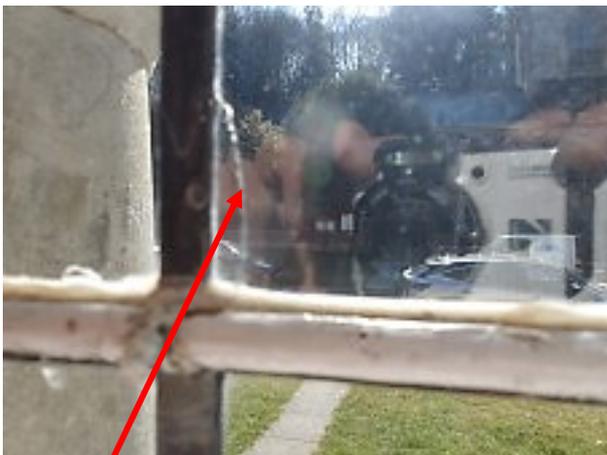
- k. There is cracked quarry to the easternmost light of the westernmost window. This does not appear to be leaking at present, and I am not particularly concerned by it.

**Cracked quarry**

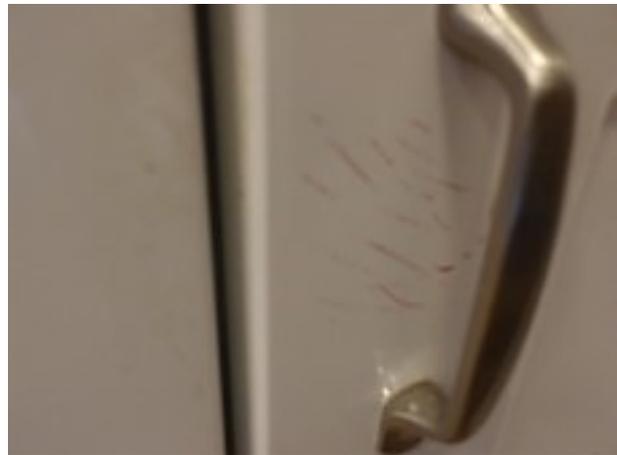
- c. The wall here sounds hollow when tapped, suggesting that it is either dry-lined or 'dot and dab'.
- d. The floor is of vinyl and in fair condition, although a little grubby around the bin.
- e. The kitchen door is a fire door. As noted at the previous quinquennial inspection, the door closer does not close it onto the latch. The closer should be adjusted so that it fully closes the door – otherwise it will not provide the fire separation for which it is designed.
- f. The kitchen fittings are generally in fair condition but there is some minor damage in places, and red markings? ink? which can probably be cleaned away.

**Minor damage & red marks (ink?)**

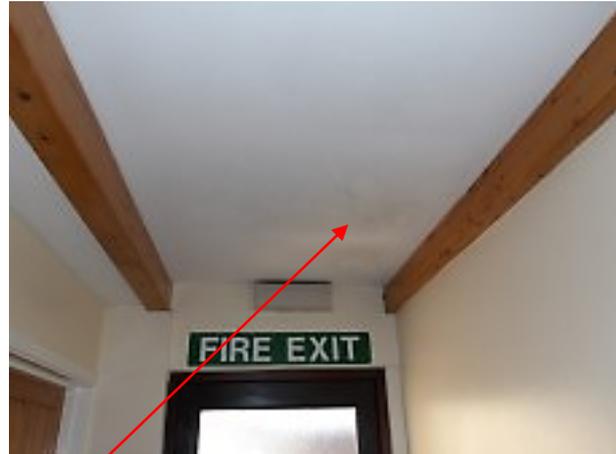
**Mould on ceiling**

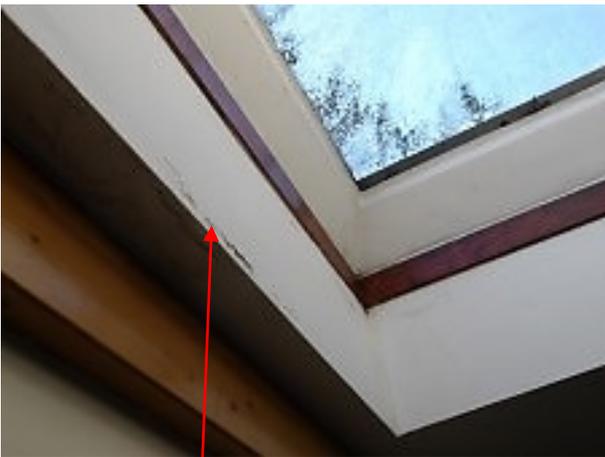
- b. There is a polycarbonate roof light. This is algae stained and would benefit from being cleaned. The reveals to the roof light have blistering paint, staining and algae on the surface in places. Rings at the edges of the roof light suggest that it may have a controllable ventilation to the curb. If so, I recommend that it be left in the ventilated position.

**Blistering paint and algae**

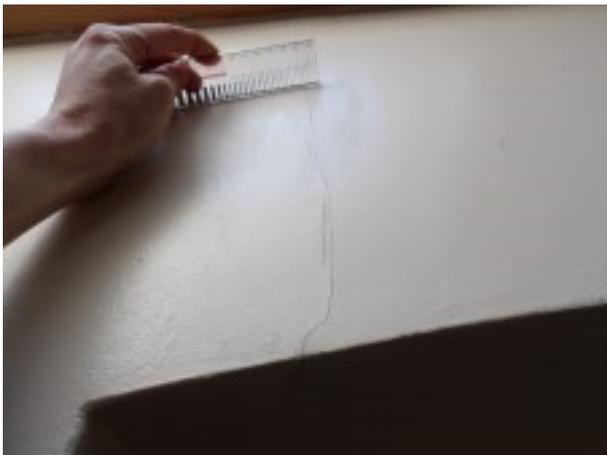
- f. The vertical cracking above the arch over the lower steps is approximately 0.15 mm in width. It is difficult to tell whether this has been filled again since the last inspection or not. I recommend that it be raked out, filled and redecorated.

**Crack measures approx. 0.15 mm**

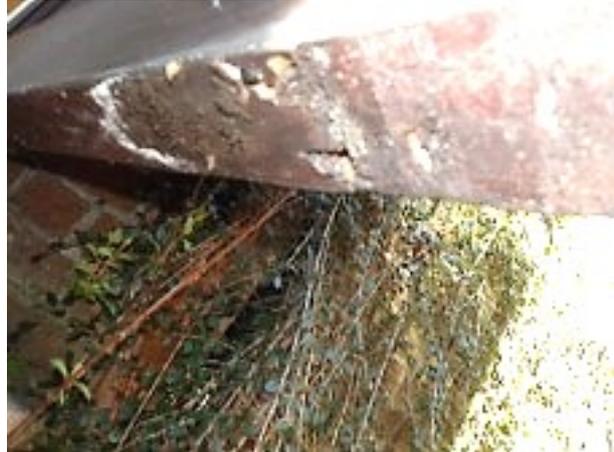
**Underside of door beginning to rot.**

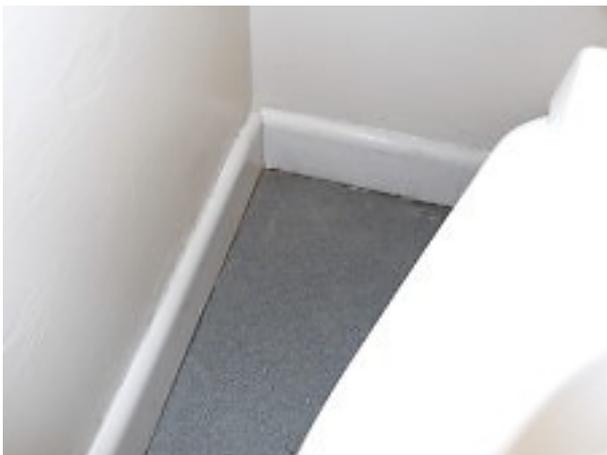
- d. The floor is of non-slip vinyl and generally in fair condition, but there is a gap between the vinyl and skirtings in places and I recommend that sealant be applied to this.

**Gap between vinyl and skirting**

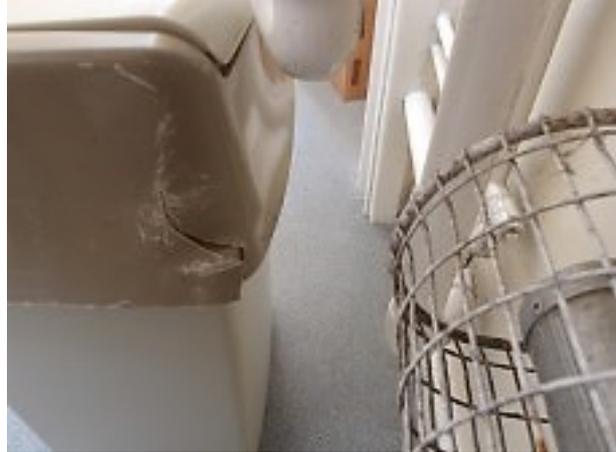
**Broken bin and rusted heating cage**

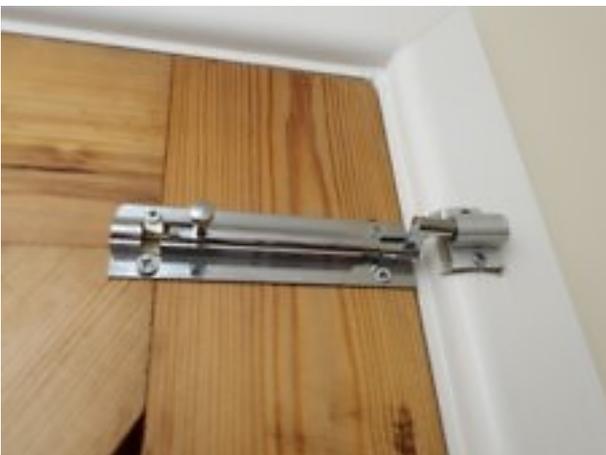
- g. The heaters were switched on at the time of inspection but were not warm. Either there is an override switch somewhere else, or they are broken.
- h. The cubicle door has a bolt at high level (with mismatched screws) and the original bolt has been covered with aluminium blanking plates. I previously recommended that the ironmongery could be improved upon by reinstating an ordinary cubicle indicator bolt, but the current arrangement was considered satisfactory. Whilst an adult of 'normal' height could reach the bolt, a child could not. If the building is used by children, the inability of them to secure the door should be considered with regard to safeguarding.

**High-level bolt**

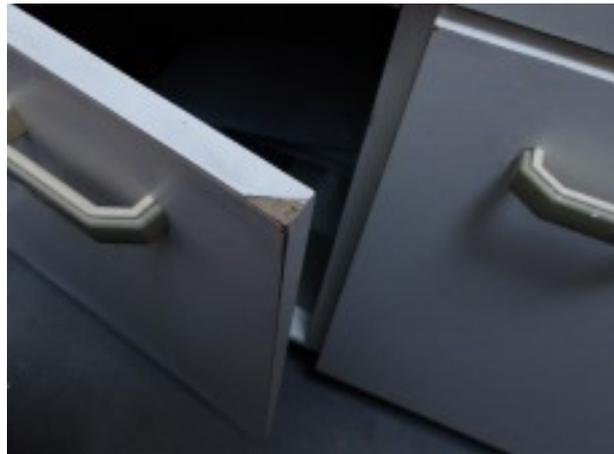
***Edging strip chipped***

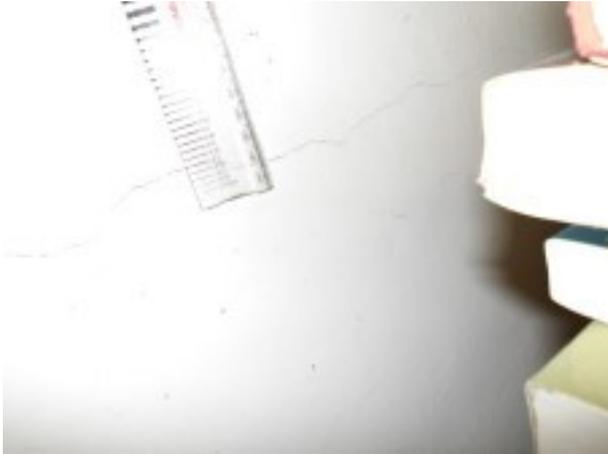
- f. I am pleased to see that the horizontal cracking noted to the south wall at my last inspection has been repaired. However, there is now some cracking at lower level, which is around 0.3 mm wide. The new cracking could be due to reduced bearing capacity of the ground caused by defective drains. I recommend the drains be checked.

**Cracking**

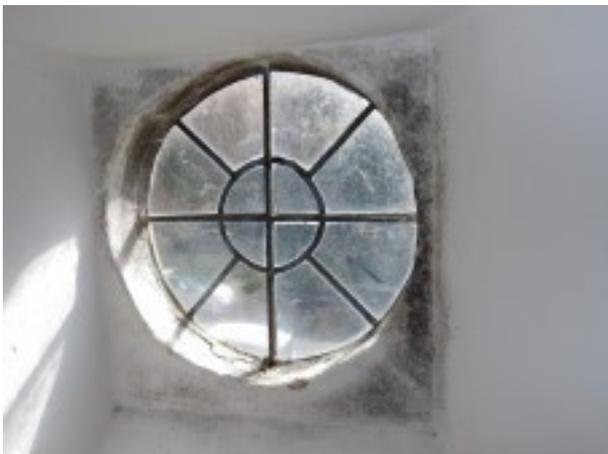
**Black spot mould & algae**

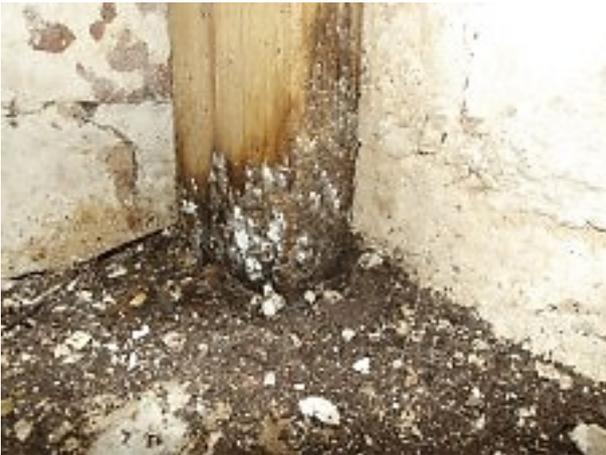
***Timber damp and rotten.***

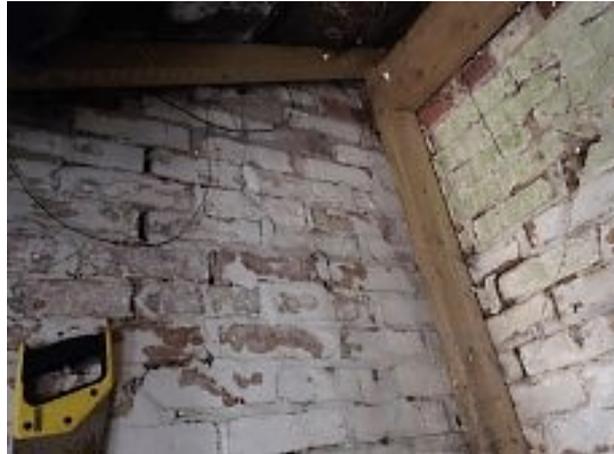
- c. The walls are of brick and have been painted internally. There are number of deep open joints, and I recommend that these be pointed.

**Deep open joints**

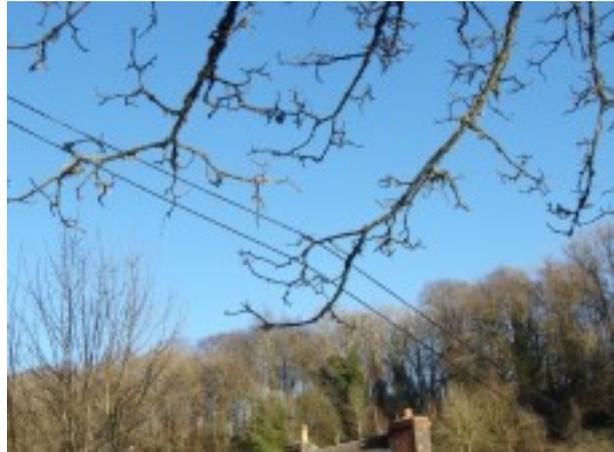
**Cable 'snagged' on branches.**

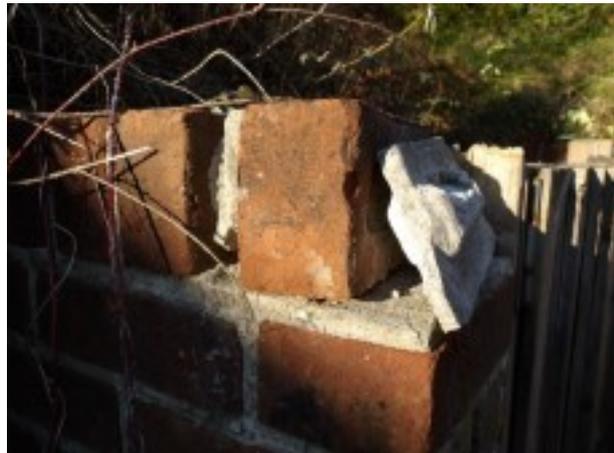
**Corner of wall damaged**

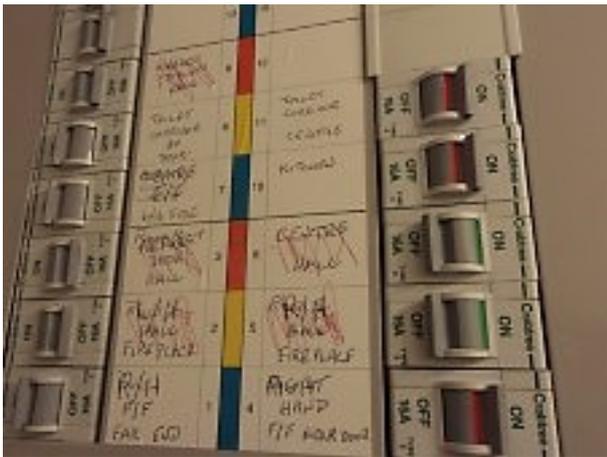
**Unclear labelling**
