# QUINQUENNIAL INSPECTION REPORT

**TREGONWELL ALMSHOUSES & READING ROOM  
MILTON ABBAS  
DORSET**

**LISTED GRADE II\***

**18<sup>TH</sup> MARCH 2025**

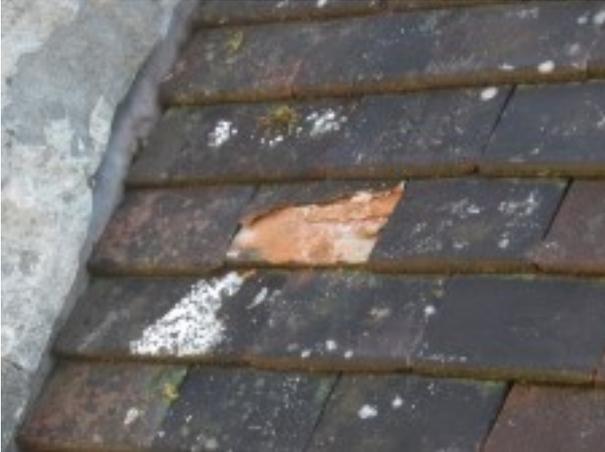
- e. The **north slope** is generally in fair condition, but there is a delaminated tile 10 courses above the stone slates and two tiles from the east end. It is probably still serviceable but will be vulnerable to further decay and so I recommend it be replaced.

**Delaminated tile**

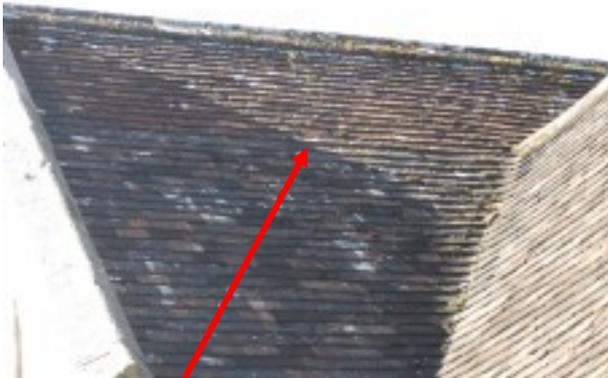
- h. To the south of the houses there is a delaminated tile approximately 1 m beneath the ridge and 2 m from the south end. This should be replaced.

**Delaminated tile**

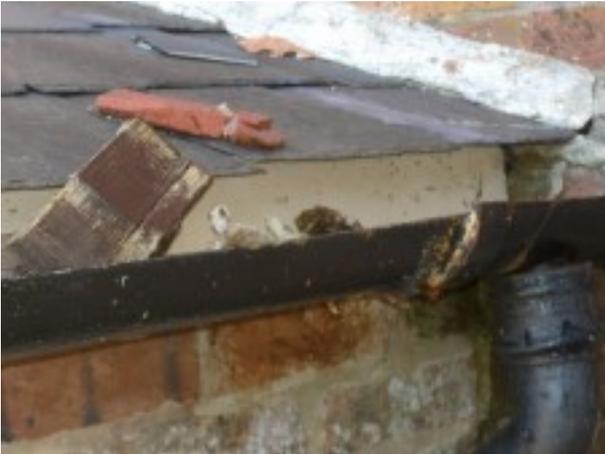
- l. The **lead roof over the corridor** by the WCs is in fair condition.
- m. The roof of the **outbuildings** behind houses 1 and 2 is south facing and of slate. I am pleased to see that the broken slates noted at the last inspection have been replaced. There are fragments of tile, slate, and mortar on this roof, which have landed from above. Thankfully, they do not appear to have cracked the slates. I recommend that this debris be cleared.

**Debris on roof & in gutter**

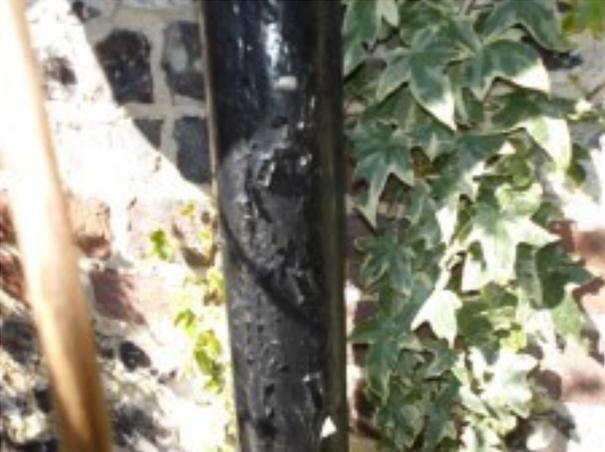
- b. The cast iron rainwater goods have been redecorated during the quinquennial period, but the paint is peeling off in some areas. Where it is peeling there appears to be sound paint beneath in most areas (although there are a few areas of localised rusting). I recommend that any areas of rust be de-rusted and “touched up” immediately, but where there is sound paint redecoration will not be required until probably 2-3 years’ time. When redecoration is undertaken it is important that the surfaces have been properly prepared so that paint adheres well and does not peel again.

**Blistering & peeling paint on downpipe**

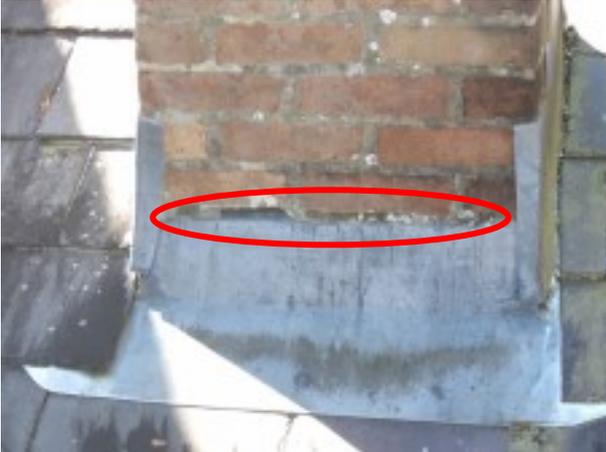
- c. The chimney to the kitchen has a little missing pointing at low level and this should be replaced.

**Missing pointing**

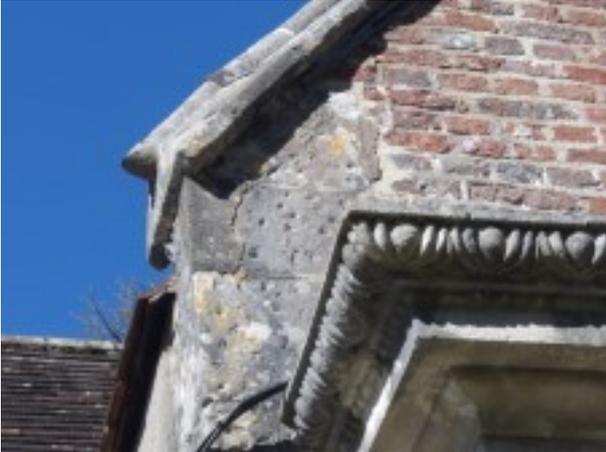
- a. The **south elevation of the Reading Room**: As previously noted; mortar repairs been undertaken to the stone in places and there is some cracking to the repair of the west quoin beneath the kneeler stone. Ideally this repair would be re-done. However, it does not appear to have worsened noticeably since the last inspection and I think it could be deferred until the next quinquennial period. Interestingly, the quoins are ‘pecked’ suggesting perhaps that they used to be rendered.

**Pecked quoins**

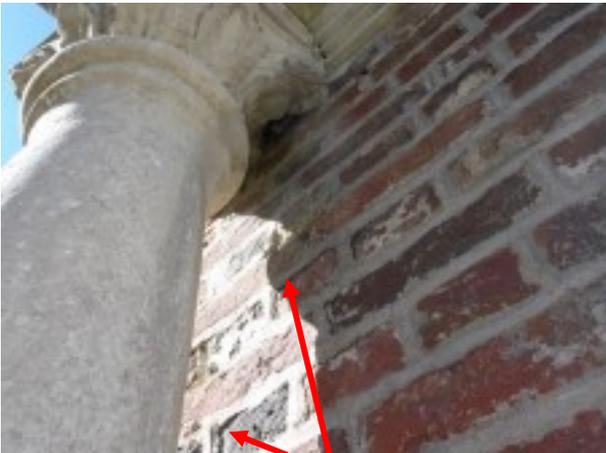
- c. At high-level beneath the capital of the westernmost column, hard mortar used for pointing has become cracked and is becoming detached. I noted this at the previous inspection and recommended that it be removed where this can be done without causing damage to the masonry. The spreadsheet records that this was done in 2022, but there is some mortar which still appears cracked and loose. This could still be firmly attached, and so left in place at that time, but it is likely that further cracking / detachment has occurred. Where there is loose mortar, it should be removed; and where this results in deep open joints, they should be pointed with lime.

**Mortar becoming detached**

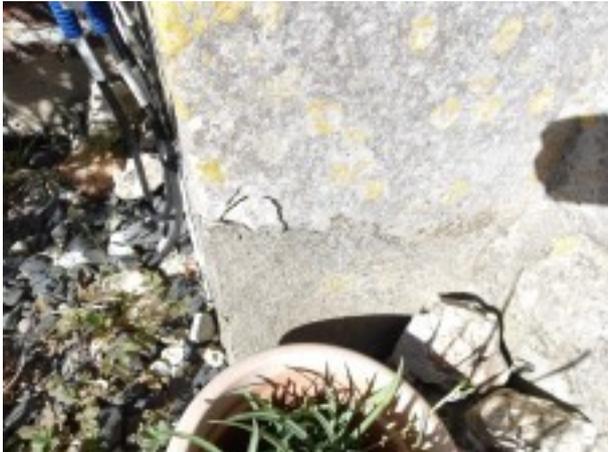
- d. Mortar repairs have been undertaken at the bottom of the west end. This is cracking. Ideally this mortar repair would be re-done, but I do not consider it to be a high priority at present.

***Mortar repair cracking***

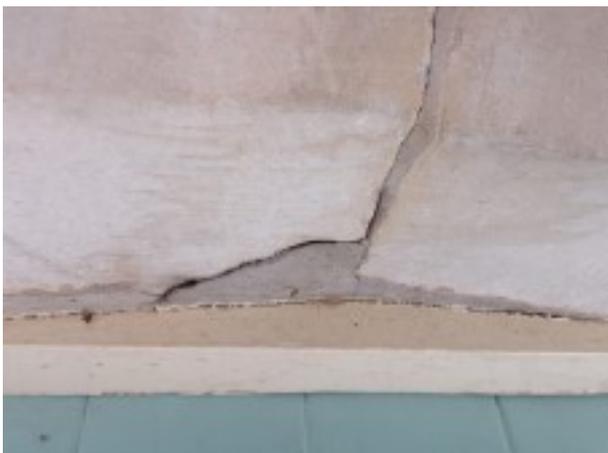
- e. The **south wall of house 2** is in fair condition. Some repointing has been undertaken at low level at the east end in a hard mortar. This is inappropriate as it will prevent evaporation of moisture through the joints and could accelerate weathering of the brickwork. To the underside of the arch over the doorway a mortar repair has been undertaken which is beginning to come away from the stone. Ideally this would be re-repaired but I do not consider it to be a high priority.

***Mortar repair becoming detached***

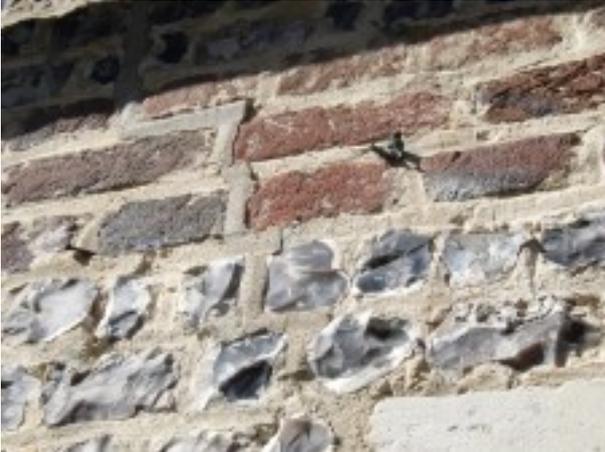
- g. The **south wall of house 1**: There is diagonal cracking to either side of the lintel over the door. To the west this has been repointed in the past using what appears to be a hard mortar, probably containing Portland cement. This pointing is coming away. I recommend that the crack here be repointed using an appropriate lime mortar. To the east the cracking has not been pointed in the past. The crack may be new but, if so, it is relatively minor. I recommend that the crack be raked out and repointed, and the date of this recorded. Then, if there is ongoing movement, the crack will re-open and could be measured to determine the rate of movement (which may be informative in determining the cause). A likely possible cause is damaged drainage, and if the crack re-opens, I suggest a camera survey of the drains be undertaken. I expect the specification for the pointing mortar will be recorded within the records of the refurbishment of 2008-2009, so this should be easy to match.

**Repointing coming away**

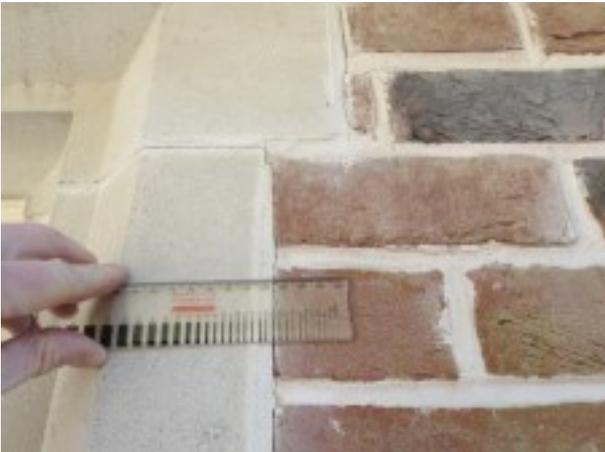
- h. The **west wall to house 1** is of brick and flint banding with stone kneelers and some stone at low level. All is in fair condition.
- i. The **west wall of the bathroom to house 1** is of brick and in good condition.
- j. The **north wall to houses 1 and 2** is of brickwork. There is a little hairline cracking between the bricks and stone window surrounds, but I'm not concerned by this at present. The widest cracks are to the westernmost window where they measure around 0.6 mm. I recommend that this be reviewed at the next inspection.

**Crack measures 0.6 mm**

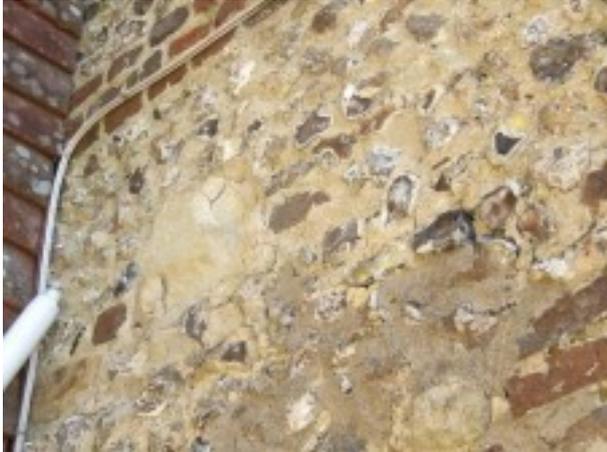
- i. The **north wall of the Reading Room** is of brick and flint. It has been repointed in the past with at least two different mortars. Some of the mortar appears loose and there is a stone which has fractured. I recommend that the mortar be removed where loose, and any deep open joints be pointed.
- m. I recommend that the fractured stone be de-frassed. It may be that there is enough sound stone remaining that no further action is required, but it is possible that new stone may need to be inserted.
- n. There is a little vegetation growing near the northwest corner, at around 2 m above floor level. This should be killed and, once dead, removed and the open joint in which it is growing should be pointed

**Repointed area & fractured stone**

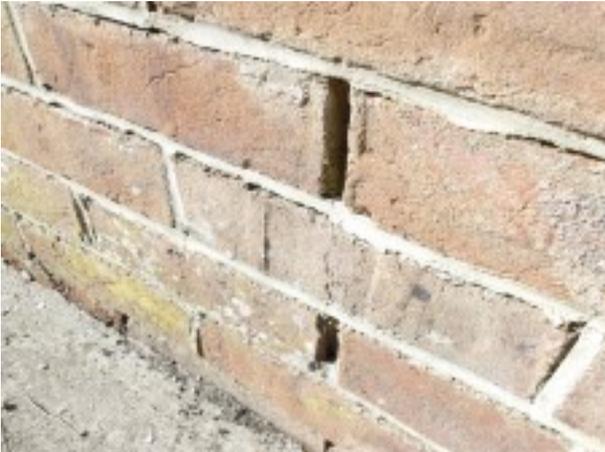
- p. The **west wall of the Reading Room toilets** is of brick, which has been pointed using a hard cement mortar. Some of the bricks are beginning to spall at low-level, but no action is required at present.
- q. The **outbuilding walls** are of brick. As noted at the previous inspection, there are gaps between the brickwork and doorframes and I recommend that these be pointed. There are also a few open joints to the brickwork and these should also be pointed. There are some spalled bricks to the western side and ideally these would be replaced. If so, it is important that any replacement bricks be a good match.

**Open joints**

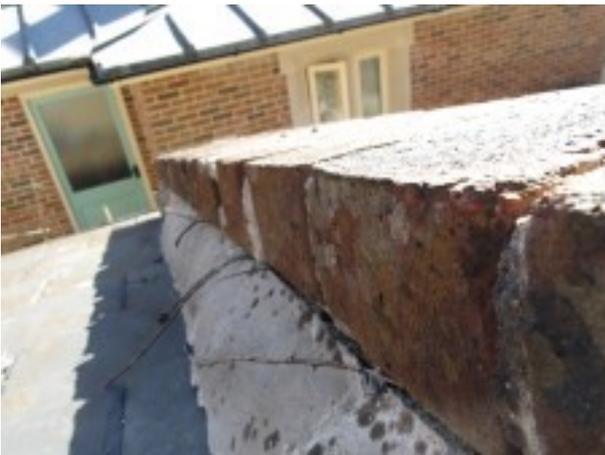
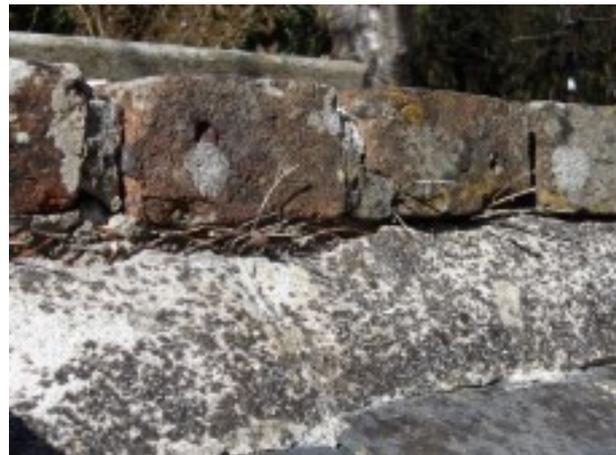
- r. There is vegetation in places beneath the brick coping on this wall. This appears to be dead and hopefully will not regrow. It has not yet displaced the masonry above. I recommend that the vegetation be raked out and the open joint in which it is growing be pointed. This also applies to the vegetation beneath the coping on the north wall of the outbuilding.

**Vegetation beneath brick coping**

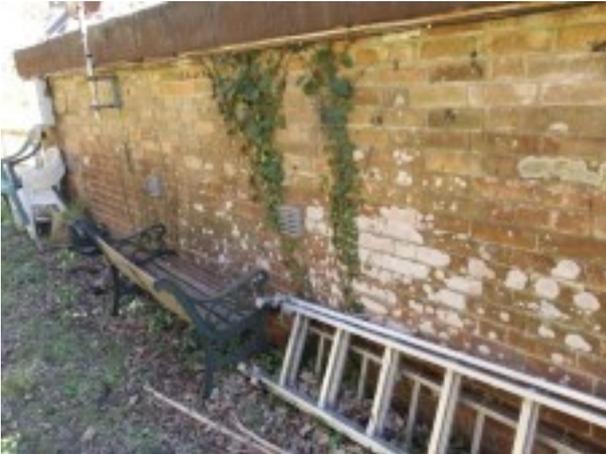
- s. The **north wall of the Reading Room toilets** is of brick. Ivy is beginning to become established on this wall and I recommend that it be killed and then removed, and any open joints in which it is growing should be pointed.

**Ivy**

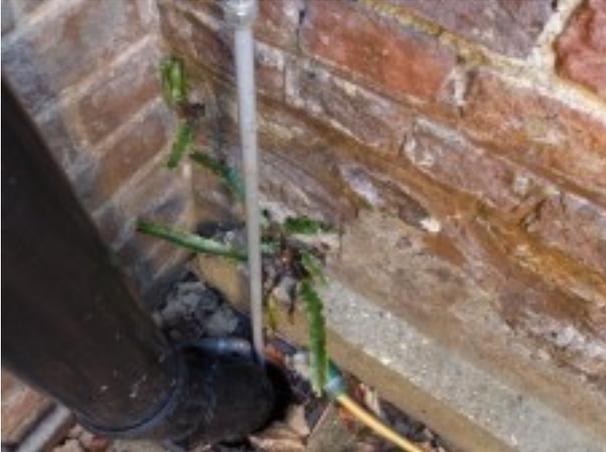
- u. The **east wall of the Reading Room toilets** is of brick and in fair condition.
- v. The **east wall of the Reading Room kitchen** is of brick and flint. There is vegetation growing within open joints at low level in the southeast corner. I recommend that the vegetation be killed and then removed and the open joint be pointed.

**Vegetation**

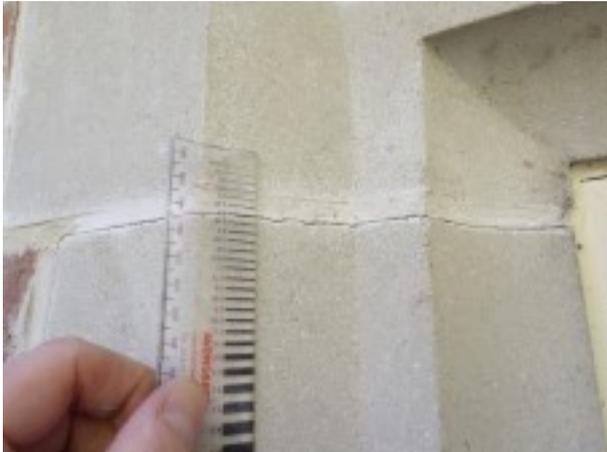
- x. The **north wall of the bathrooms to houses 3 and 4** is of brickwork and in fair condition.
- y. The **east wall of the bathroom to house 4** is of brick. There is a little cracking around the masonry to the windows. I recommend this be reviewed at the next inspection. This currently measure up to 0.4 mm.

**Crack 0.4 mm width**

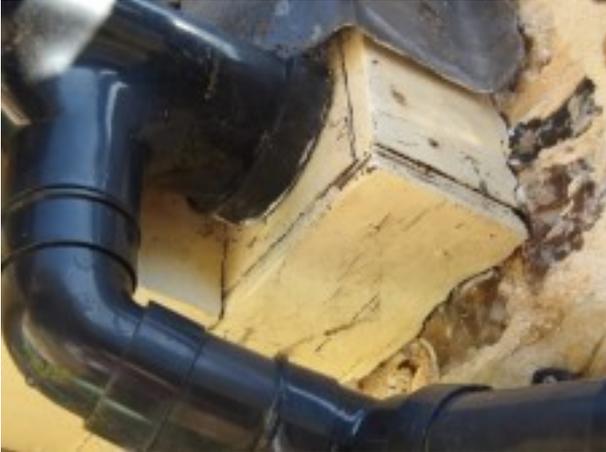
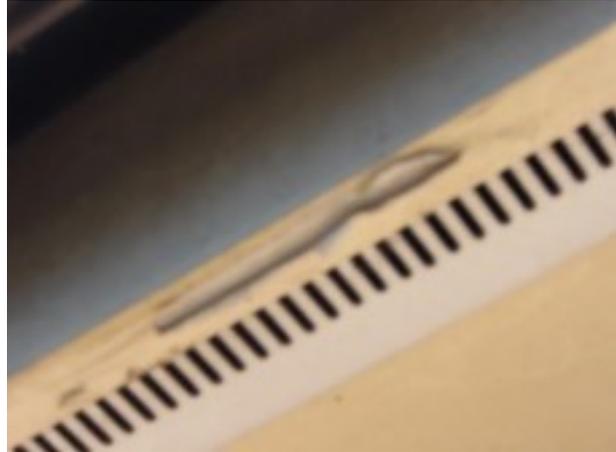
- a. There is an exposed wall plate on the south side of the Almshouses. This is heavily decayed in places and has suffered “woodworm” in the past; but this appears to be historic damage and no further action is required at present.
- b. The soffits and fascias to the north of houses 1 and 2 are generally in fair condition, but in need of redecoration in places.

**Woodwork in need of redecoration**

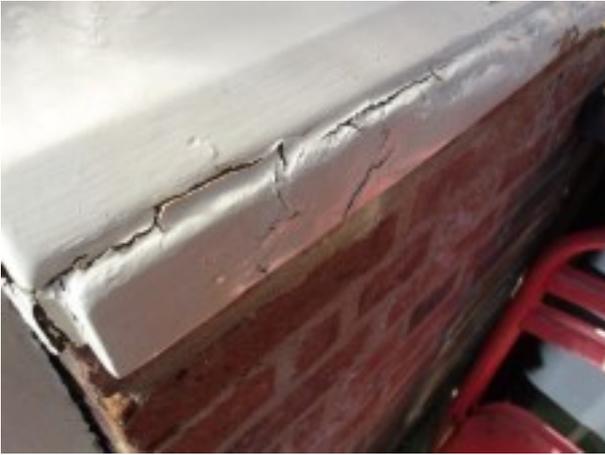
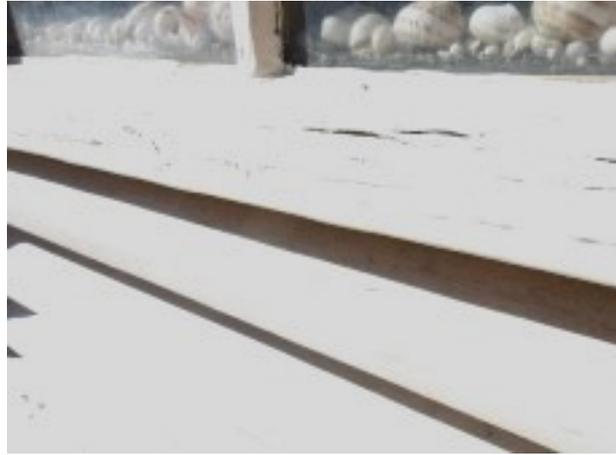
- f. The outbuilding joinery: the windows have been redecorated over rot; the hinges have also been painted over and the window painted shut. The timber is soft to the touch. Similarly, rotten timber has been painted over to the louvres. It is important that surfaces be properly prepared and repaired before decorating. I recommend that the rotten timber be cut out, and the windows be repaired and redecorated.

**Rotting timber beneath paintwork**

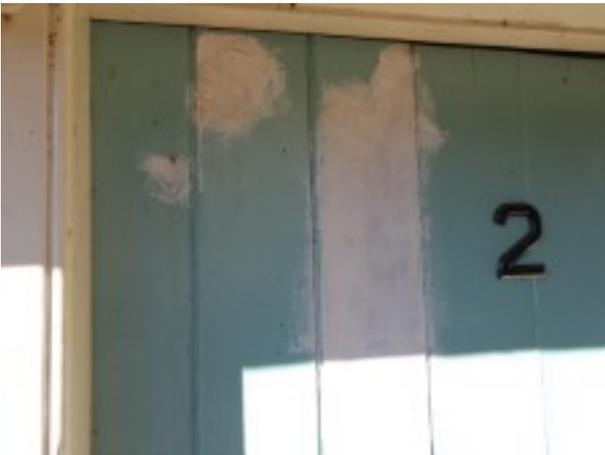
- g. There are some areas to the door of store 2 which appear to have been repaired and then primed or undercoated with white paint. I recommend that the redecoration be completed.

**Incomplete redecorations**

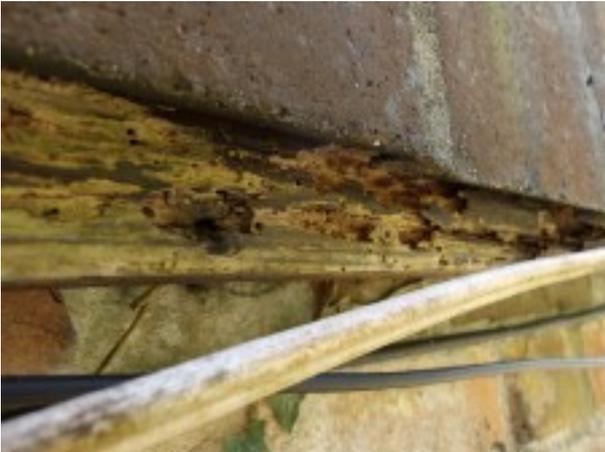
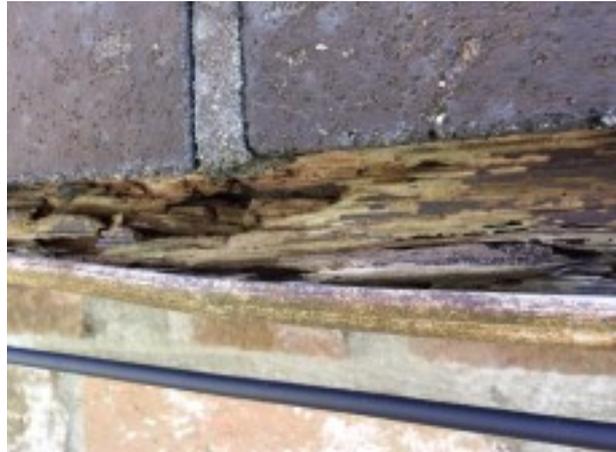
- h. To the north of the WC toilets there is a timber fascia which is heavily decayed. I recommend that the rotten fascia be replaced. To achieve this it will be necessary to remove the wiring that is fixed to it, and probably also to take off the ridge tiles. Consideration could be given to fixing the wiring to the wall to facilitate the replacement of the fascia.

**Fascia heavily decayed**

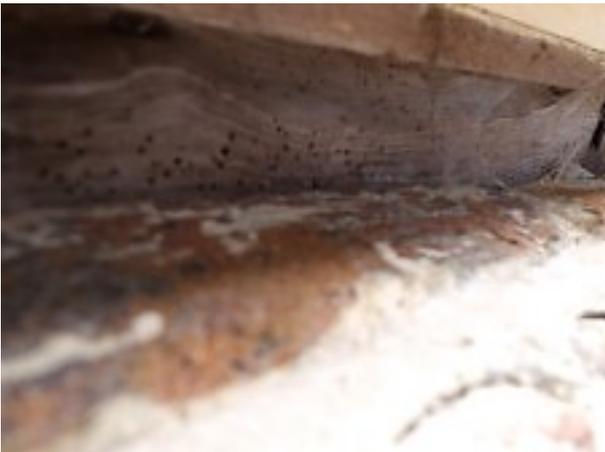
- i. The fascia to the east side of the Reading Room WC requires redecoration.
- j. The fascia to the east side of the kitchen is in fair condition. It will be due for redecoration within the next couple of years. There is a timber soffit above this which has “woodworm” holes consistent with *Anobium punctatum* (common furniture beetle). I recommend that it be locally treated.

**“Woodworm” holes**

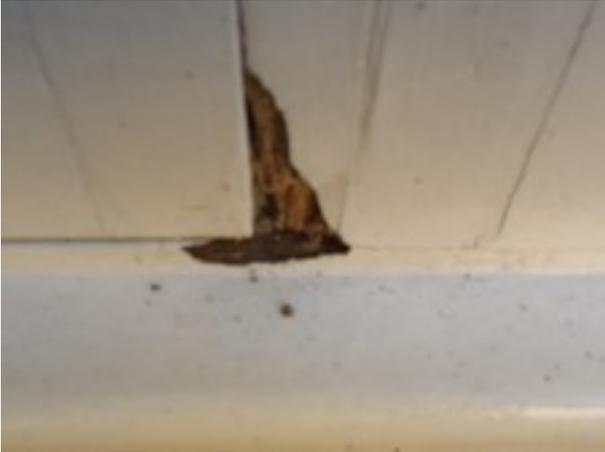
- k. The kitchen window is rotten at the bottom of the mullion. I recommend that new timber be spliced in.

**Rotten timber**

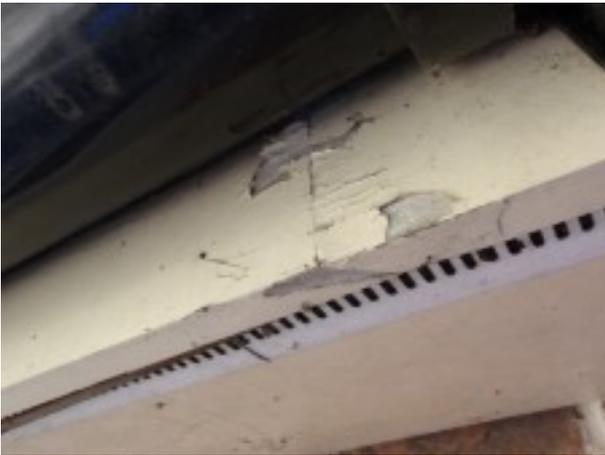
- I. The fascia to the north of the bathroom to houses 3 and 4 is due for redecoration.

**Fascia due redecoration**

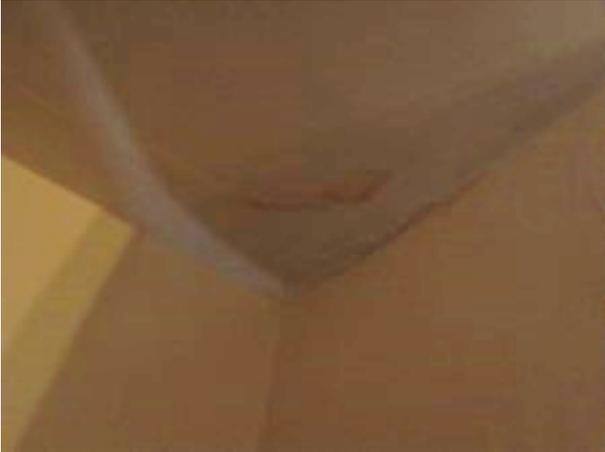
- a. The ceiling is papered and painted. I'm pleased to see that the staining around the chimney is far less than at the last inspection. There is still a little staining to the north edge of the chimney and ideally this would be 'touched up'.

**Staining.**

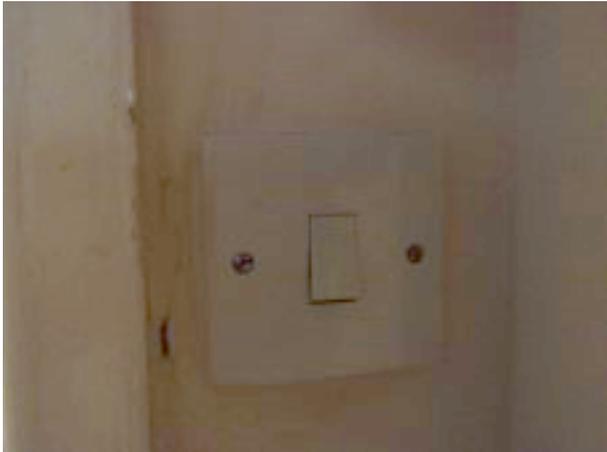
- a. The ceiling is plastered and painted and in good condition.
- b. The walls are plastered and painted, with tiling above the kitchen units - all is in fair condition. There is a little damage by the light switch and I recommend that this be repaired.

**Damage by light switch**

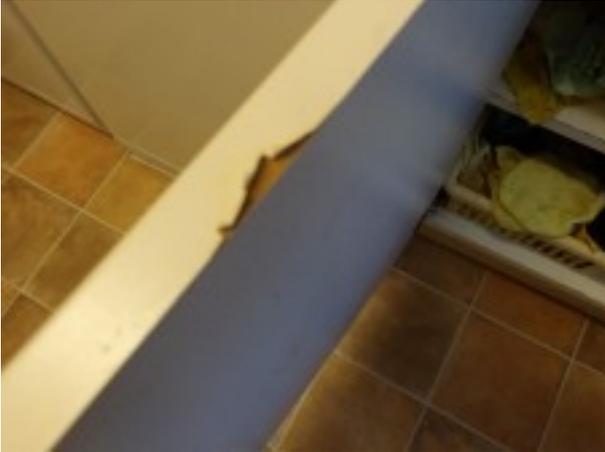
- d. The kitchen door is in fair condition.
- e. The kitchen window is of plain diamond patterned leaded glazing set within steel framing. There is an opening casement to the west. This springs open but is operable. The glazing is in fair condition. There is internal ferramenta and secondary glazing.
- f. The kitchen fittings are generally in fair condition although the laminate is peeling on the top of the cupboard door beneath the sink.

**Damage to door**

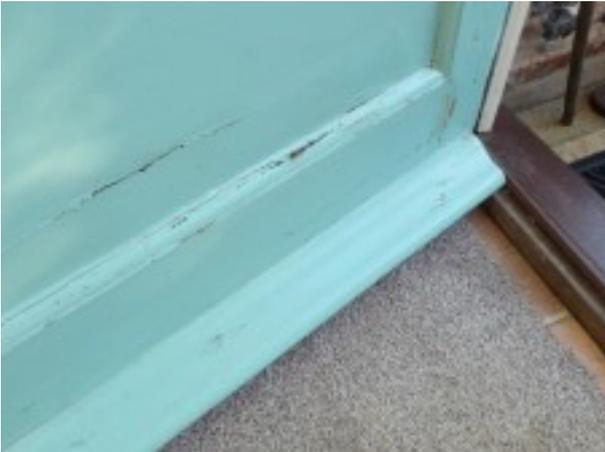
- a. The floor is of vinyl and in fair condition.
- b. The external door is of timber, double glazed. There is rot at the bottom. I recommend the bottom of the door be repaired and then the door be redecorated.

**Rot at base of door**

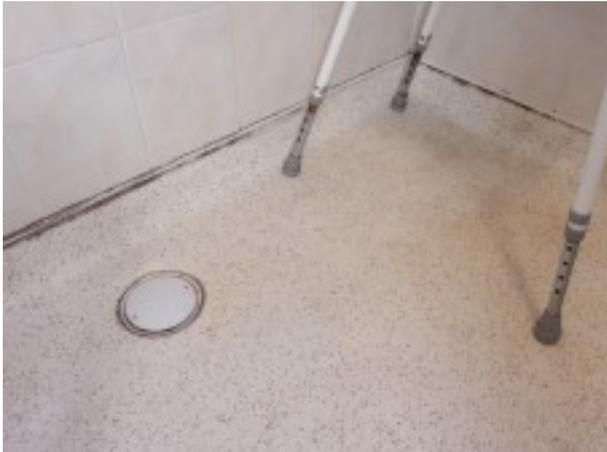
- d. The floor is of nonslip vinyl. There is black spot mould around the top of the coving and the vinyl is loose around the outlet - it appears that there is a slight gap around the trim around the top of coving. Perhaps water is getting here and then tracking down beneath the floor towards the outlet or it could be that the floor is not sealed against the outlet.

**Black spot mould**

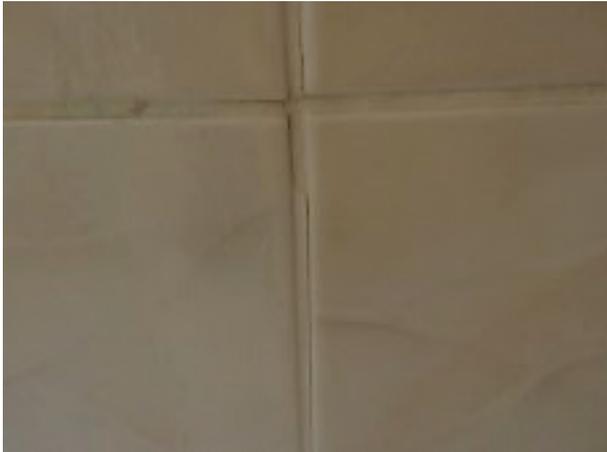
- a. The ceiling is plastered and painted and in fair condition.
- b. The walls are tiled, apart from the west wall which is painted. The tiling to the east wall is uneven (beneath the shower in particular) and there is cracking between the tiles - they bulge out and they sound hollow when tapped. I think they have become detached from the wall behind although the whole wall sounds hollow when tapped and is probably dry lined. I suggest that one of the tiles beside the cracked grouting be removed to see whether the tiles are well bonded. If so, the cracked areas can simply be re-grouted. If not, re-tiling will likely be required. When this is done, it would be prudent to allow for expansion by filling internal corners with sealant rather than grout. There is also some surface crazing to a couple of the tiles on the south wall.

**Cracking between tiles**

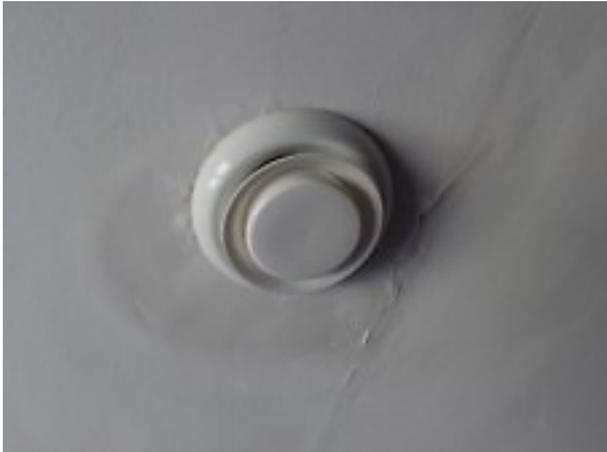
- a. The ceiling is plastered and painted. As noted at the previous inspection, there are cracks which follow the lines of the boarding. At the previous inspection there was efflorescence and blistering of paint around the ventilator. This has now been touched up and improved since the last inspection, but the area is still scarred and could perhaps be touched up more neatly.

**Repaired area untidy**

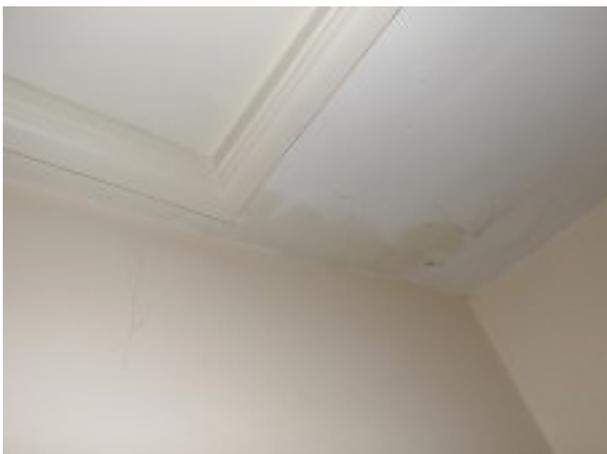
- a. The ceiling is plastered and painted. It is generally in fair condition but there is a little staining near the loft access hatch and the decorations could be 'touched up' here.

**Staining near hatch**

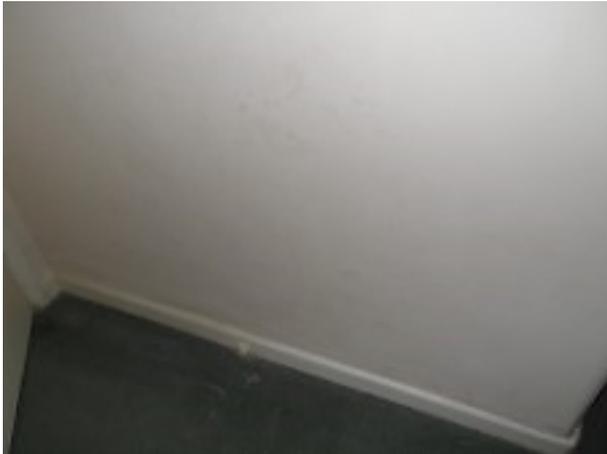
- b. The walls are papered and painted and in fair condition. At my last inspection there was damp staining to the north wall opposite the kitchen door at around 0.5 m above floor level. This appears to be greatly reduced since the last inspection, but there is still some staining. The skirting board has a moisture content of 13% (which is dry). The staining appears to be historic.

**Historic staining**

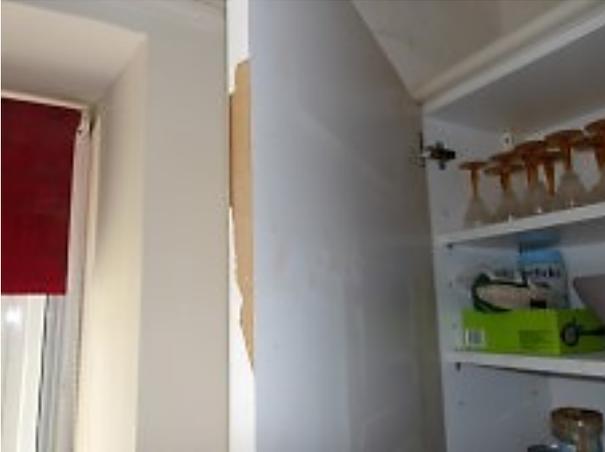
- c. The windows are of rectangular plain leaded glazing within steel frames and there is internal secondary glazing, all in fair condition.
- d. The floor is of vinyl and in fair condition.
- e. The kitchen fittings are looking ‘tired’, particularly the high level units above the hob.
- f. The door to the southernmost cupboard wobbles and has lost some of the laminate from its edge. I recommend that the laminate be repaired, or door replaced.

**Damage to edge of cupboard door**

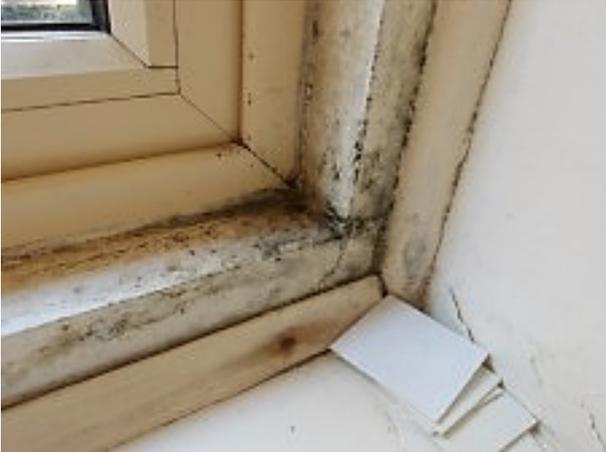
- d. The window does not close onto its latch and the handle is loose - I recommend that this be repaired. There is black spot mould on the window, I recommend that the mould be cleared and the room be better ventilated during and for a period after showering, to reduce the mould. The 'hit-and-miss' vent was closed at the time of inspection. I expect the positive pressure ventilation system would be more effective if the vent is opened, so that humid air is pushed out of the building- it would be worth checking the operation manual for the system.

**Mould**

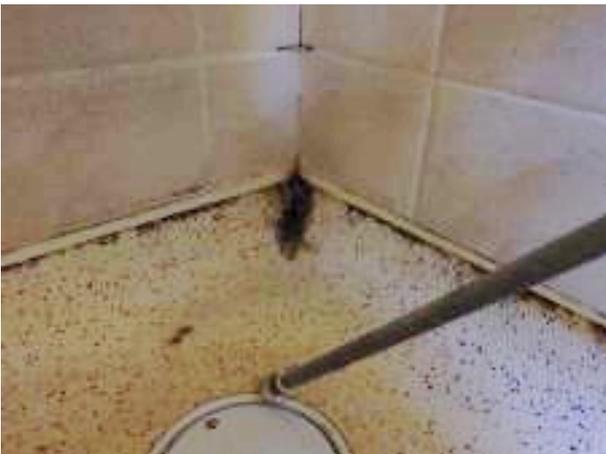
- e. The sanitaryware is in working order. There were clothes drying beneath the shower, so I did not turn the shower on to test it.
- f. The floor is of nonslip vinyl. At the last inspection it was torn beneath the shower, I recommended that it be repaired, there is now mould on it, and it is difficult to tell what condition it is in.

**Mould covering tear?**

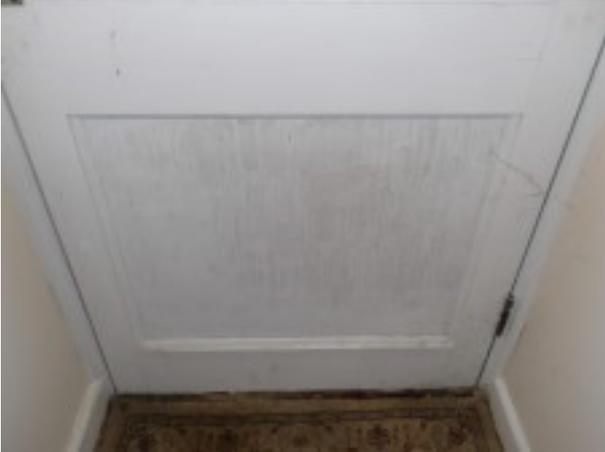
- a. The ceiling is plastered and painted and in fair condition.
- b. The walls are plastered and painted and in fair condition.
- c. The floor is of nonslip vinyl; there is a rug towards the northern end.
- d. The external door has black spot mould on the surface at low level. This space is not well ventilated; consideration should be given to providing a vent in the door.

**Black spot mould**

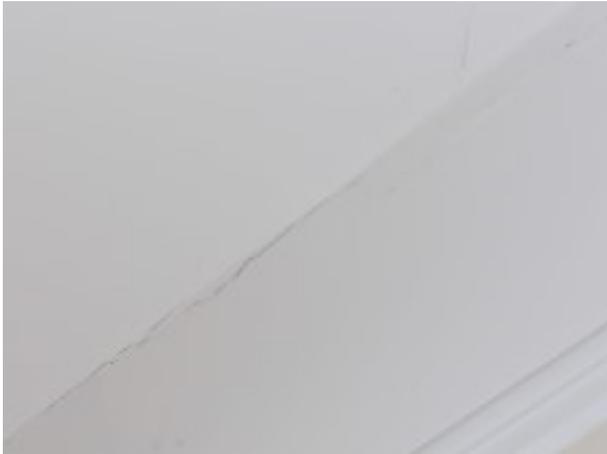
- a. The **ceiling** is plastered and painted between exposed timber joists which span in an east-west direction and rest on corbels. It is fair condition on the whole, but there is a little cracking in places, mainly at the junction between the ceiling and walls but also against some of the timbers. I am not particularly concerned by this, but the cracks should be filled when the ceiling is next redecorated.

**Cracking between ceiling and wall...**

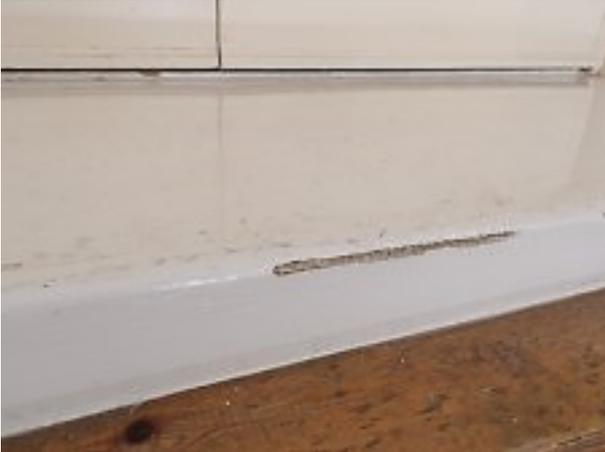
- d. The cill to the serving hatch is in poor decorative order and I recommend that this be redecorated.

***Scruffy cill to serving hatch***

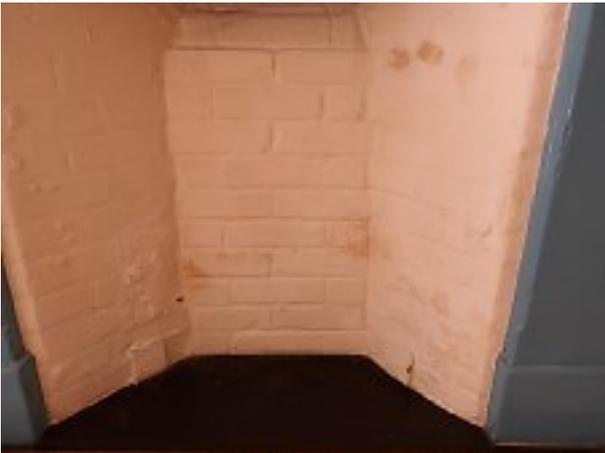
- e. The dado panelling is in fair condition.
- f. The fireplace is painted. There is damp staining at low level.

***Damp staining in fireplace***

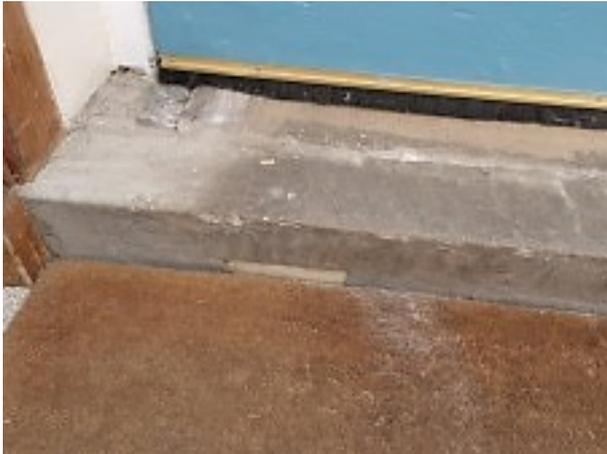
- g. The mantelpiece over the fire has something sticky on the edge and would benefit from being cleaned.
- h. The **floor** is of vinyl, in good condition. There is a little localised damage to the step by the main entrance and ideally this would be repaired, but I do not consider it to be a high priority. Consideration could be given to adding a contrasting nosing to the step for safety.

**Damaged step**

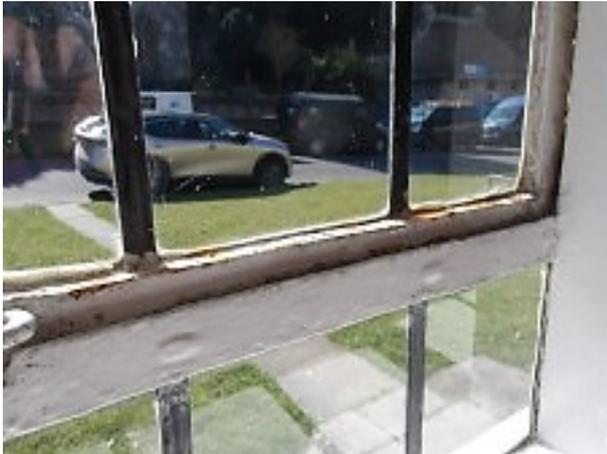
- j. The south windows are of leaded lights with rectangular cames. Some of the lights rattle when tapped indicating looseness of the cames, most notably the glazing to the easternmost casement. The cames are damaged in places and I recommend re-leading this casement. The frame to is rusting at the bottom and this casement has seized - I was unable to open it. I recommend that it be re-leaded, eased and redecorated.

**Rusting frame**

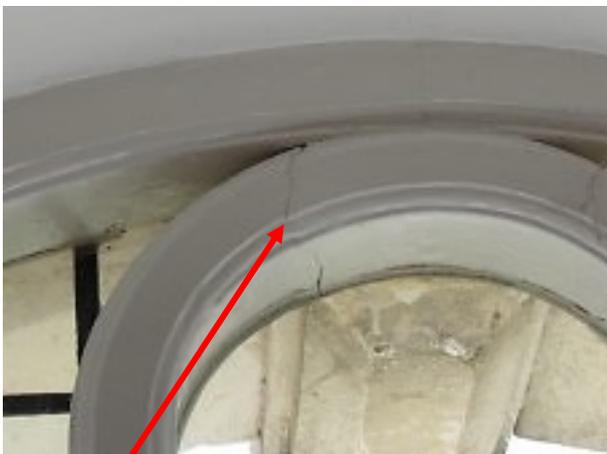
- l. The frame to the round window at the top of the easternmost light has a little cracking that the top. This should be filled when the window is next redecorated.

**Cracking above window**

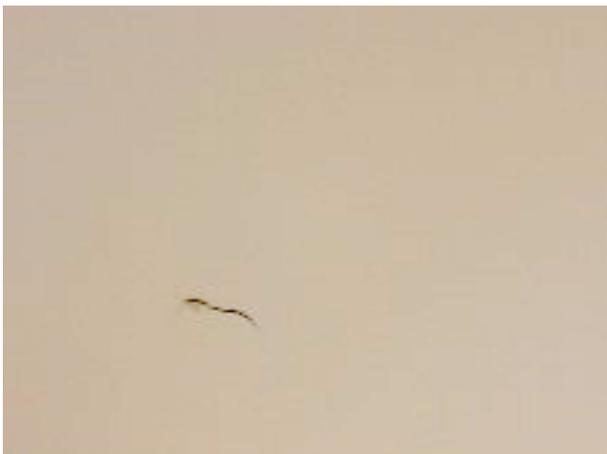
- a. The ceiling is plastered and painted. There is some cracking above the window and the skim has 'popped' over some of the fixings. I recommend that the plaster be repaired when the ceiling is next decorated.

**'Popped' plaster beneath fixings**

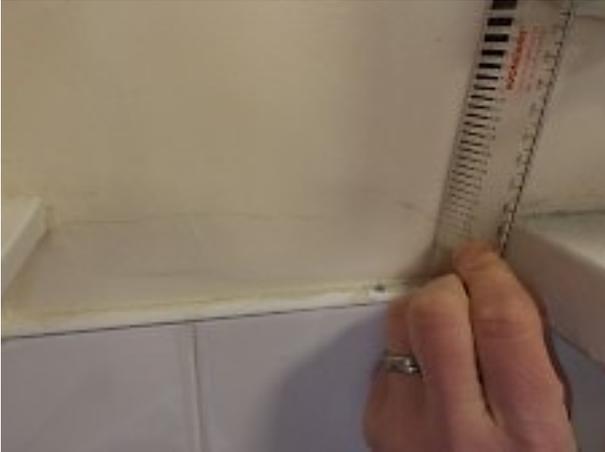
- b. The walls are plastered and painted with tiling above the countertop. As noted at the previous inspection, there is cracking near the southeast corner. This appears to have been filled since the last inspection at which it measured 0.2 mm but reopened to hairline width (around 0.15 mm).

**Crack has re-opened**

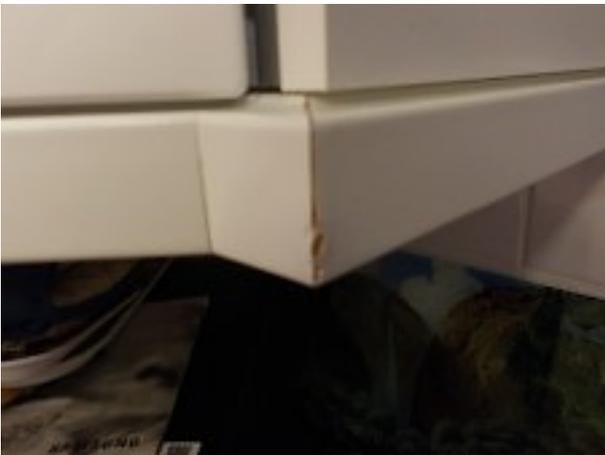
- c. The wall here sounds hollow when tapped, suggesting that it is either dry-lined or 'dot and dab'.
- d. The floor is of vinyl and in fair condition, although a little grubby around the bin.
- e. The kitchen door is a fire door. As noted at the previous quinquennial inspection, the door closer does not close it onto the latch. The closer should be adjusted so that it fully closes the door – otherwise it will not provide the fire separation for which it is designed.
- f. The kitchen fittings are generally in fair condition but there is some minor damage in places, and red markings? ink? which can probably be cleaned away.

**Minor damage & red marks (ink?)**

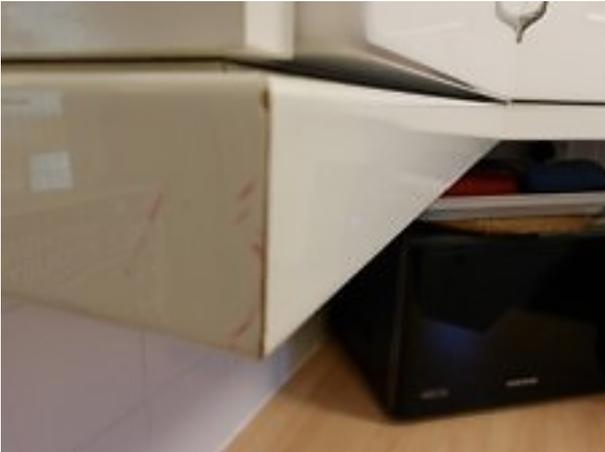
**Minor damage & red marks (ink?)**

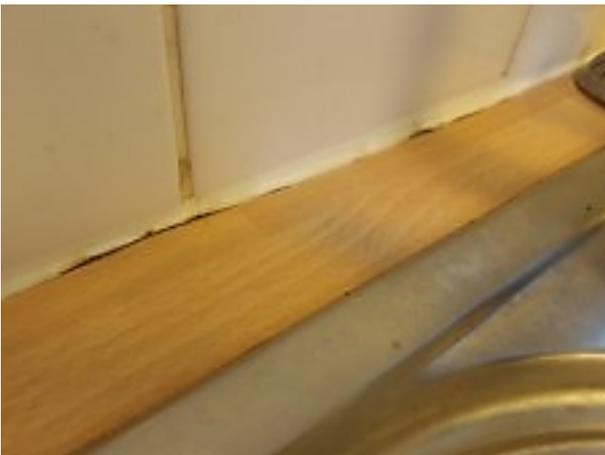
- g. Staining beneath the trap indicates that it has leaked in the past, but I found no leaking at the time of inspection. The sealant behind the taps is peeling and I recommend that this be redone so that water splashed behind the sink does not damage the worktop.

**Peeling sealant**

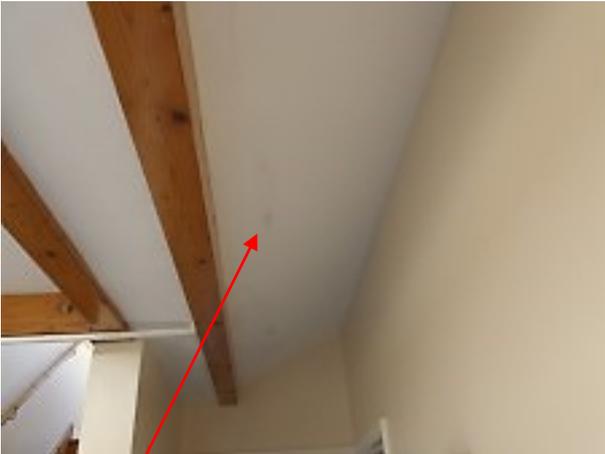
- a. The ceiling is plastered and painted. I am pleased to see that it has been redecorated since the last inspection, but there is a little black spot mould beneath on the sloping section of ceiling by the WC's. The gutter above this area leaked in the past and it's possible that the mould is caused by ongoing leaking, but I consider it more likely to be due to condensation. There is also a little mould on the ceiling by the fire exit door. I recommend improving ventilation to the corridor. At the time of inspection, the trickle vent to the Velux roof light was closed - I recommend that this be kept open and this may be sufficient.

**Black spot mould**

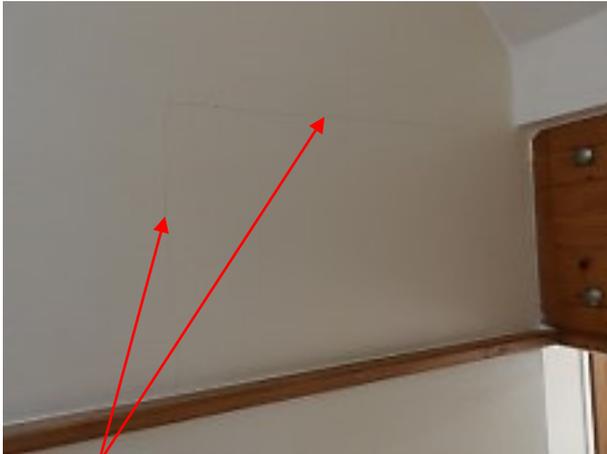
- c. There is a little cracking above and below the Velux window above the stairs. I recommend these cracks be filled when the ceiling is next redecorated.
- d. Above the top landing the ceiling is marked/scuffed and would benefit from redecoration.
- e. The walls are plastered and painted. The external walls sound hollow when tapped, indicating that they are dry lined or 'dot and dab'. There is some minor cracking following the joints of the plasterboard. I am not particularly concerned by this.

**Cracks following plasterboard joints**

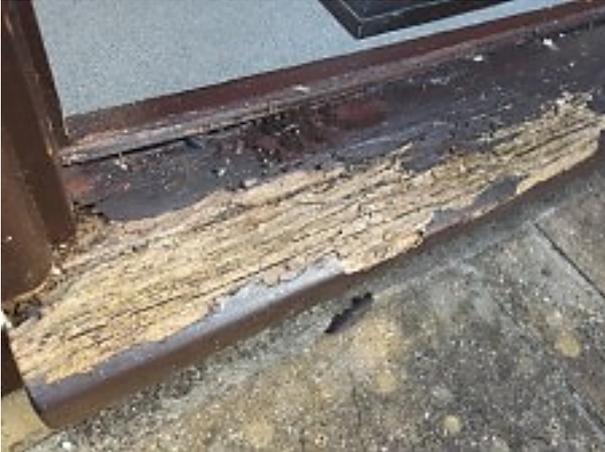
- g. The floor is of non-slip vinyl and in fair condition.
- h. The door between this space and the lobby between the kitchen and main room is a fire door with Georgian wired panelling, in fair condition.
- i. The external door is a fire exit door of timber with obscured glass panel. The door is in working order and the exit hardware is in good working order, but at the bottom where it meets the rotten cill it has begun to decay. The cill is rotten; it is soft to the touch and so heavily decayed that replacement would be more appropriate than repair I recommend adding a weather bar with drip at the bottom of the door so that the cill is not as exposed.

**Rotten cill**

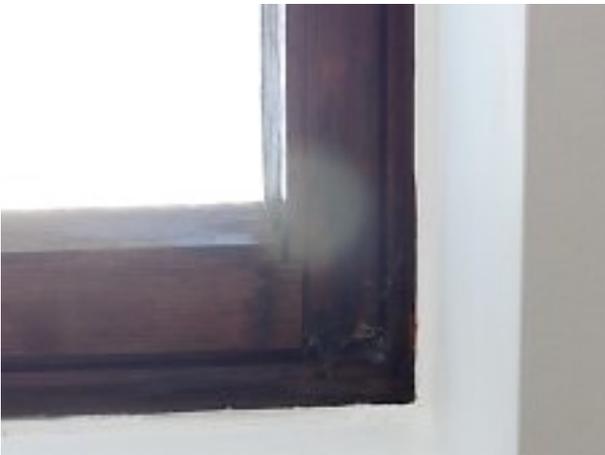
- a. The ceiling is plastered and painted, and in fair condition. I am pleased to see that it has been redecorated since the last inspection.
- b. There is a large Velux window with obscured glazing. It has a little damp staining at the lower corners and one of the joints is beginning to come apart. Velux windows have a trickle vent at the top. At the time of inspection this was closed, and I recommend that it be left open to passively ventilate the room.

**Damp staining in corner and joint separating**

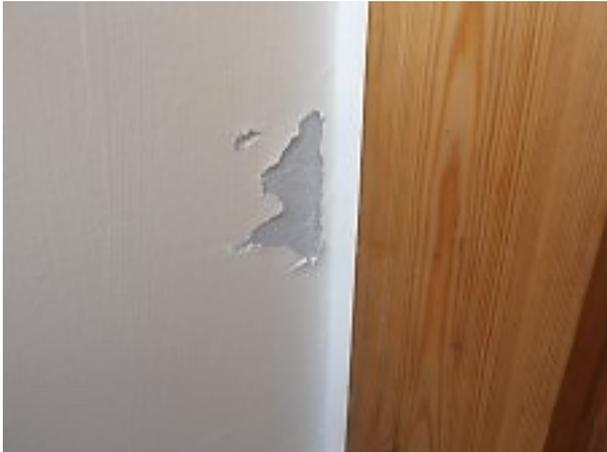
- c. The walls are plastered and painted, with tiling behind the urinals. The walls are in fair condition but there is some localised damage by the door.

**Localised wall damage**

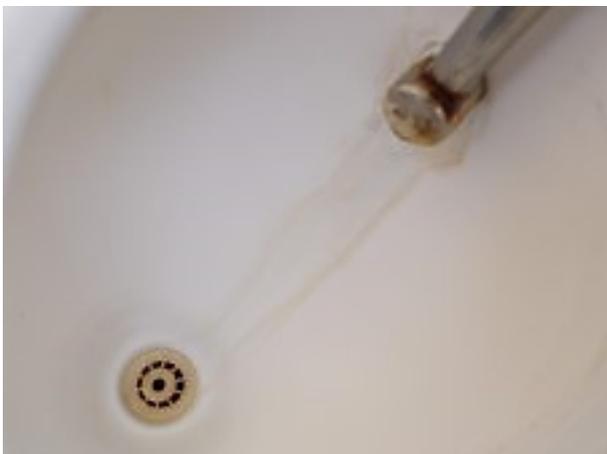
- e. The sanitaryware is in working order but stained and looking somewhat tired. The taps are stiff, there is rusting on the urinal pipework, and the toilet is somewhat shabby. It would be good to refurbish the toilets.

**Rusted urinal pipework, and staining.**

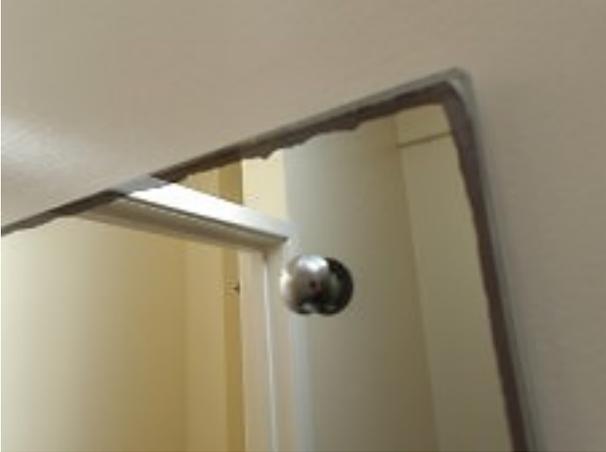
- f. The fixtures and fittings are 'tired': the edge of the mirror is looking ragged and there is rusting to the safety cages over the heaters, the bin is broken, etc.

**Edge of mirror is scruffy**

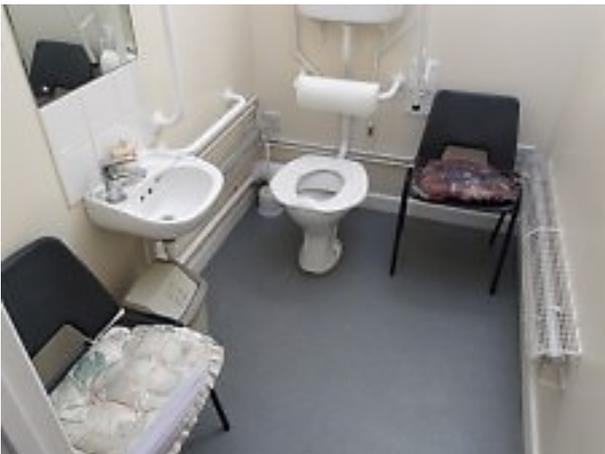
- g. There are two chairs within the lavatory. These occupy space designed for wheelchair manoeuvring - I recommend that they be removed.

**Chairs creating obstruction**
