# QUINQUENNIAL INSPECTION REPORT

**TREGONWELL ALMSHOUSES & READING ROOM  
MILTON ABBAS  
DORSET**

**LISTED GRADE II\***

**18<sup>TH</sup> MARCH 2025**

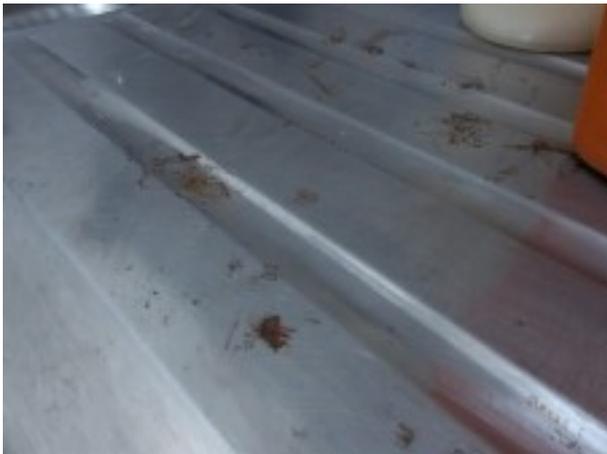
- d. There is wall tiling above the sink. This is in fair condition but there is black spot mould on the grout. I recommend that this be cleaned away.
- e. The sink has an integral drainer which has rusting on the surface. Ideally this would be removed, but in this utilitarian space I do not consider it a priority. The drawer catches and there is some minor damage to the top corner of cupboard door – again, in the store room, this is not a great concern.

***Rusting drainer.***

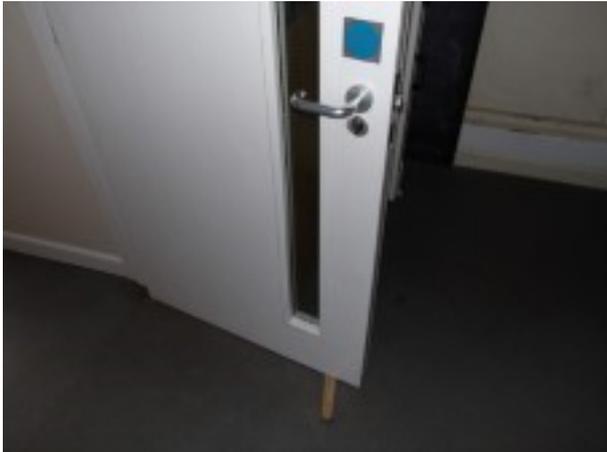
***Fire door wedged open***

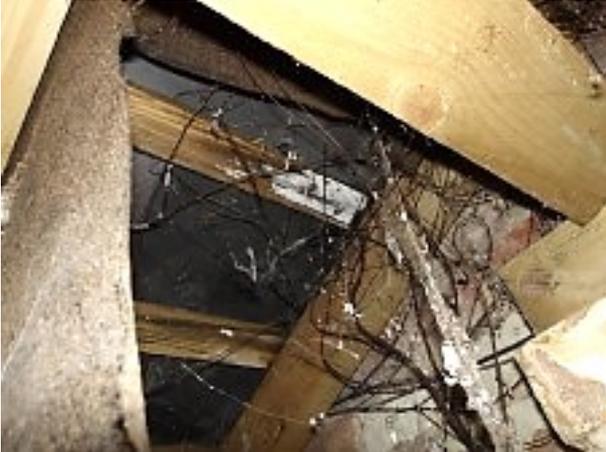
- a. There is no ceiling. The roof structure comprises simple rafters supported at mid-span on softwood purlins and there is bitumen felt above the rafters. The felt is hanging down in one corner and there is vegetation growing at the gap between the roof and the wall and also coming through the wall itself in places. Where the felt is hanging down the battens are visible, and these appear to be damp and rotting where they are against the west wall. I recommend that the vegetation be cleared. It would be good to re-roof the outbuildings during the quinquennial period.

***Decaying batten, vegetation, torn felt***

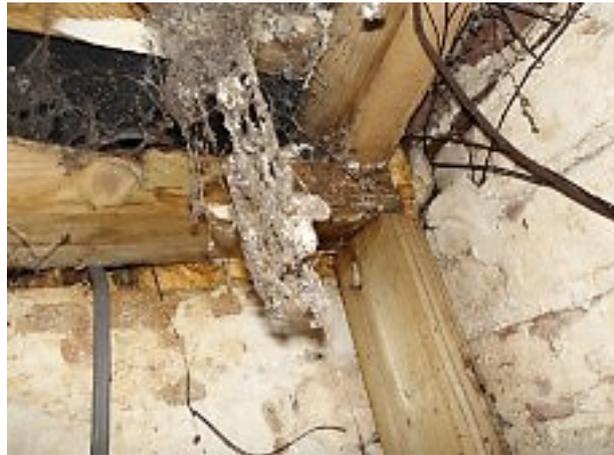
- b. The timber post in the southwest corner and end of the wall plate above are rotting. The bottom of the post has a moisture content of 55% and the end of the wall plate 59%. I recommend that the post supporting the end of the wall plate be replaced and new timber be spliced on to replace the rotten end of the wall plate. When this is done, the timber should be isolated from the damp masonry.

***Timber damp and rotten.***

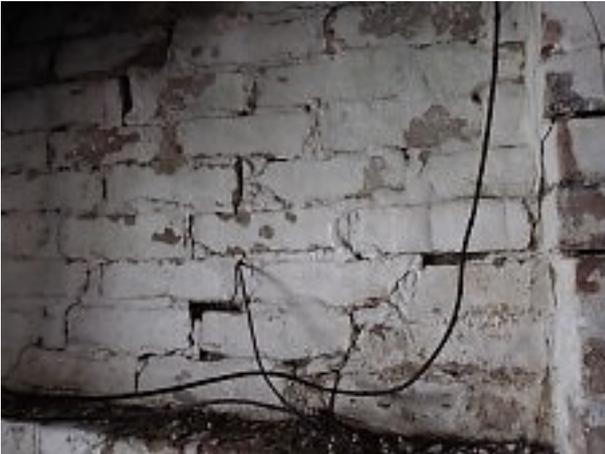
- c. The walls are of brick and have been painted internally. There are number of deep open joints, and I recommend that these be pointed.

**Deep open joints**

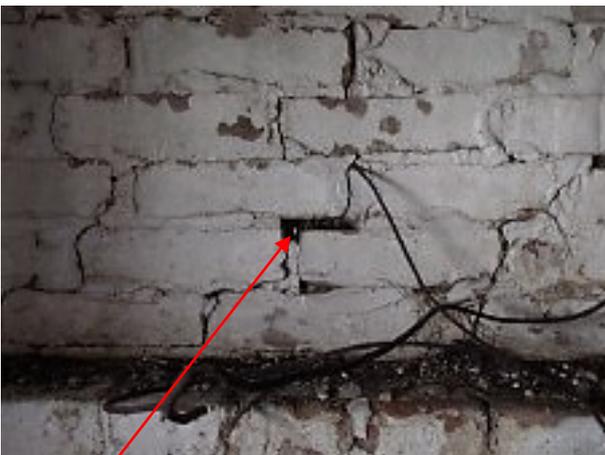
- d. The west wall is cracked in places and there is vegetation growing through the cracks. Daylight can be seen through the open joints in places.

**Daylight visible, vegetation**

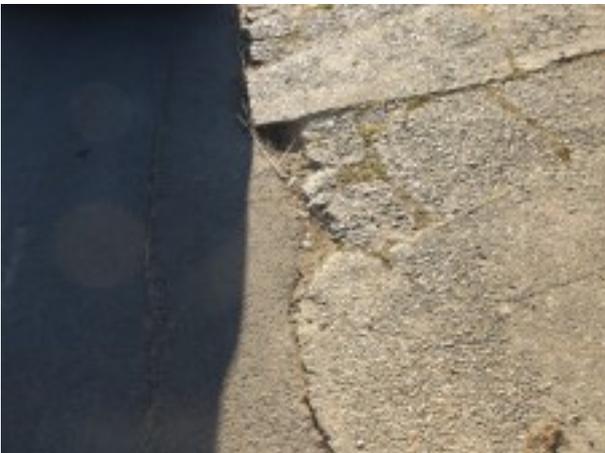
- a. **To the south** of the Almshouses is a small neatly planted border and then a lawn between the houses and the road. There is a path of concrete paviours leading from the road to the Reading Room, and this is in fair condition.
- b. There are a number of benches and chairs on the lawn and these would benefit from decoration within the next year or two.
- c. To the west end of the lawn there is a concrete driveway. This is cracked in places, with some vegetation growing in the cracks. I recommend that the worst cracks be repaired and in particular where the end of the drive meets the road. The concrete has decayed such that there is a step. This should be repaired so that there is a gentle ramp.

**Step between tarmac and concrete.**

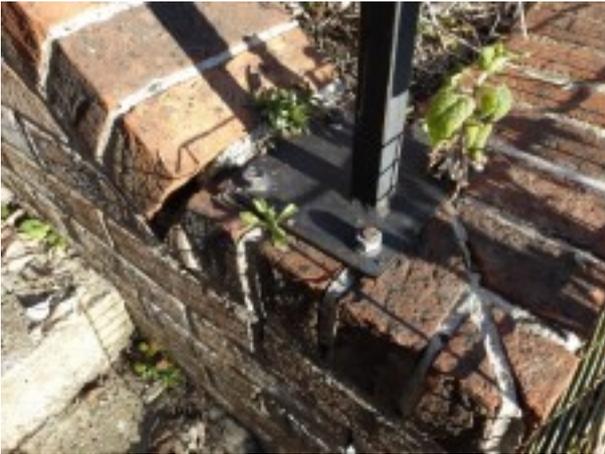
- h. There is brick walling forming planters and terracing to the eastern part of the car park. This is in fair condition.
- i. There are concrete steps rising to the north lawn flanked by iron railings. These are generally in good condition but there is an open joint at the bottom of the railings and this should be filled. There is also vegetation growing on the coping; this should be killed and removed and any open joints in which it is growing should be pointed. The handrails are rusting and should be de-rusted and redecorated. Consideration could be given to painting contrasting nosings to the steps for improved safety.

*Open joints and vegetation*

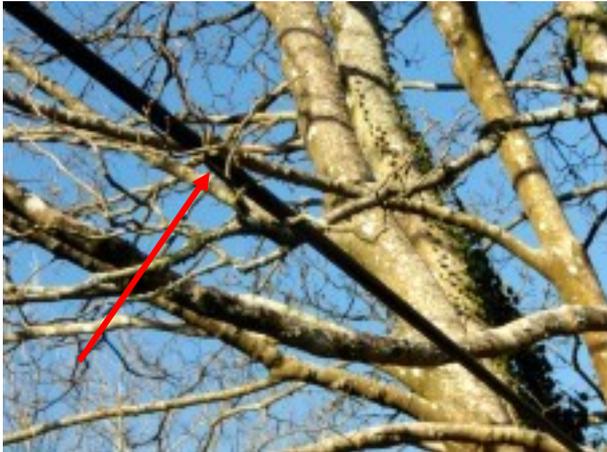
- k. The **north boundary** is of stock fencing. There are a number of trees and I recommend that all large trees be periodically inspected and pruned as required for safety by a qualified arborist (tree surgeon).
- l. At my last inspection I noted that the overhead electrical cable was touching branches and recommended that the branches be pruned clear. This recommendation still stands. There are also smaller electrical cables from the telegraph pole. Some of these have snagged on branches. All of the trees should be kept clear of the cables.

**Branches touching electrical cables**

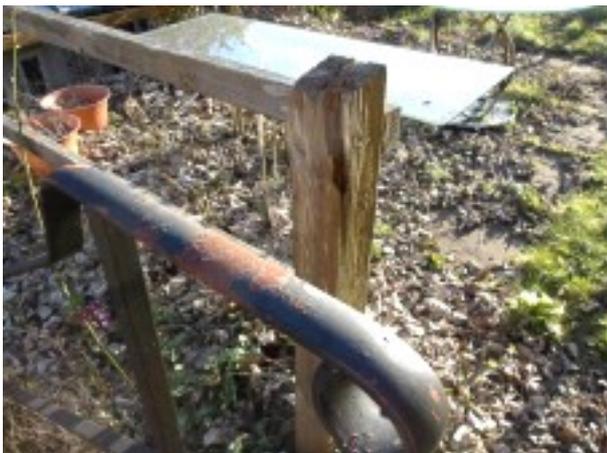
- p. Near the southeast corner of the raised area there are concrete steps with steel railings leading down to the lower area. The railings are rusting and due for decoration. Consideration could be given to painting contrasting nosings on the steps for improved safety.

**Rusting handrail**

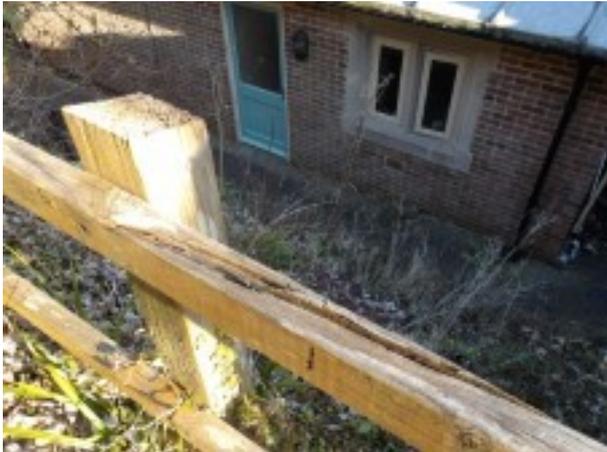
- q. There is timber guard railing which is rotting. It is still serviceable (I gave it a good shove) but I expect the most badly decayed rails will need to be replaced within the next year or two. As they are for safety, they should be replaced before they decay to the extent that they cannot support somebody falling against them. There are brambles overhanging the steps and I recommend these be pruned back.

**Rotting timber guard**

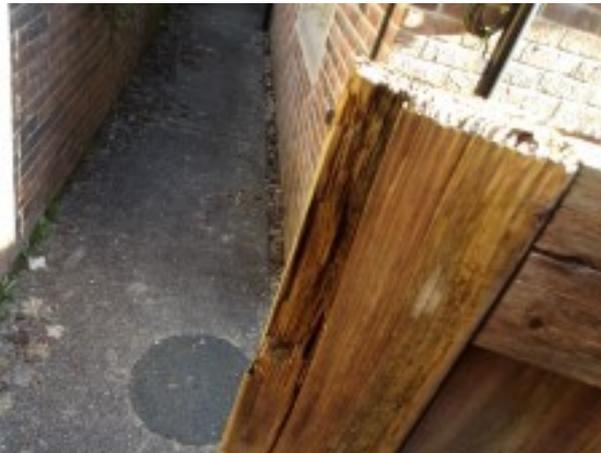
- r. There is a concrete walkway around the north of Houses 3 and 4 and brick planters to the north of this. The planters are in fair condition but the plants could benefit from tending.
- s. There are timber gates to a wheelie-bin store in the northeast corner of the walkway. These are serviceable but would benefit from redecoration and they are rotting in places - I expect they will need to be replaced by the end of the quinquennial period. The inside of this area is overgrown and I recommend the vegetation be cleared. The corner of the brick wall forming the wheelie-bin area is broken and should be repaired.

**Timber gate rotting**

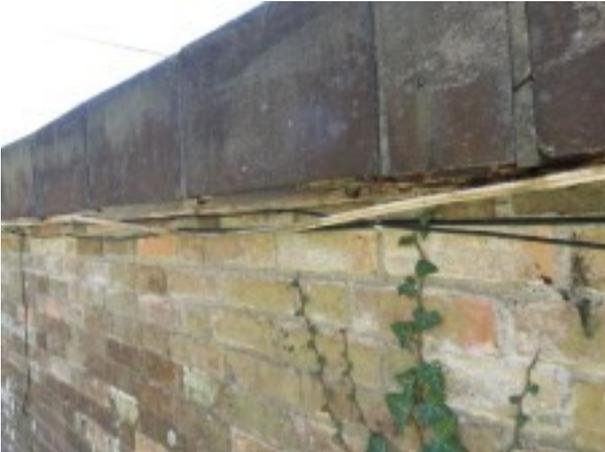
- i. The horizontal cable approximately 1 m above floor level of the west wall of House 1 has a number of broken clips and should be resecured.
- j. There are cables fixed to the fascia on the north of the WC toilets which have become detached and should be resecured.

**Cables detached from fascia**

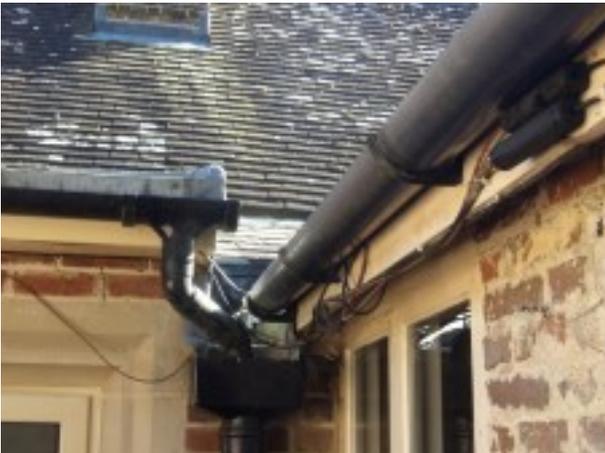
- k. The wiring at high level is untidy in places and could be improved.

**Untidy & loose cabling**
